Overview-Level Geotechnical Investigation and Assessment Ladysmith Harbour Ladysmith, BC

Ministry of Forests, Lands and Natural Resource
Operations
Crown Land Opportunities and Restoration Branch
4th Floor, 780 Blanshard Street
Victoria, BC
V8W 2H1

Report Number: 09-1436-5008/6000

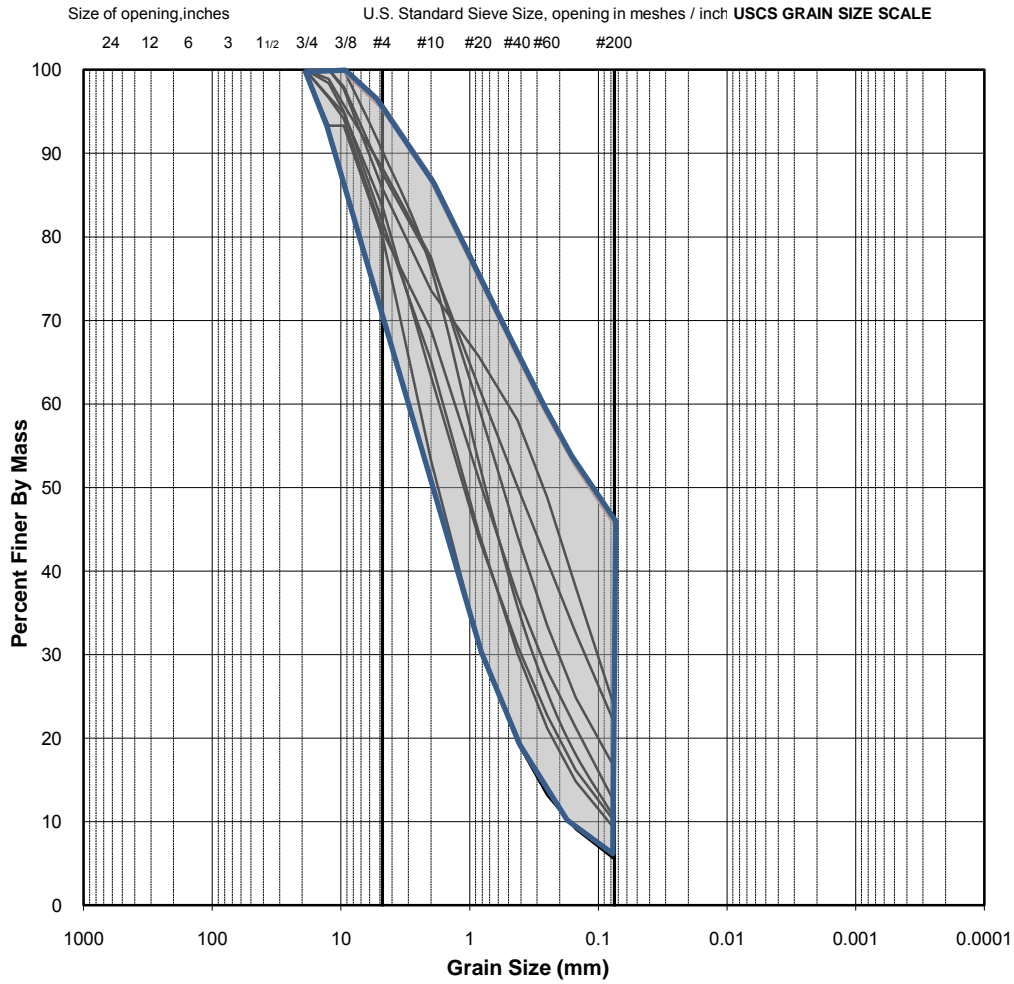
Project No.: 09-1436-5008/6000	Figure C-1
Client: Ministry of Agriculture and Lands - Crown Land Restoration Bra	Material Specification: Coal
Project: Ladysmith Harbour - Stage 1 Preliminary Site Investigation	Method: SPLIT, WASHED
Location: Ladysmith, BC

Laboratory particle size testing was conducted on samples collected from this material. The results of the particle size testing indicate that the median particle size for the coal waste ranges from about 0.3 mm – 1.8 mm. The fines content (percent passing the USS 0.075 mm sieve size) ranged broadly from about 5 to 46 percent. Typically the percentage of fines content ranged from about 10 to 24 percent. Finer particle size distributions were observed in samples obtained from near the bottom of the coal deposit in boreholes BH09-05 and BH09-01, with a median particle size of approximately 0.1 mm. It is possible that some intermixing of the coal material with the silty sand deposit underlying it may have occurred. An envelope of particle size distribution curves for the samples tested is provided in Figure C-1 in Appendix C.

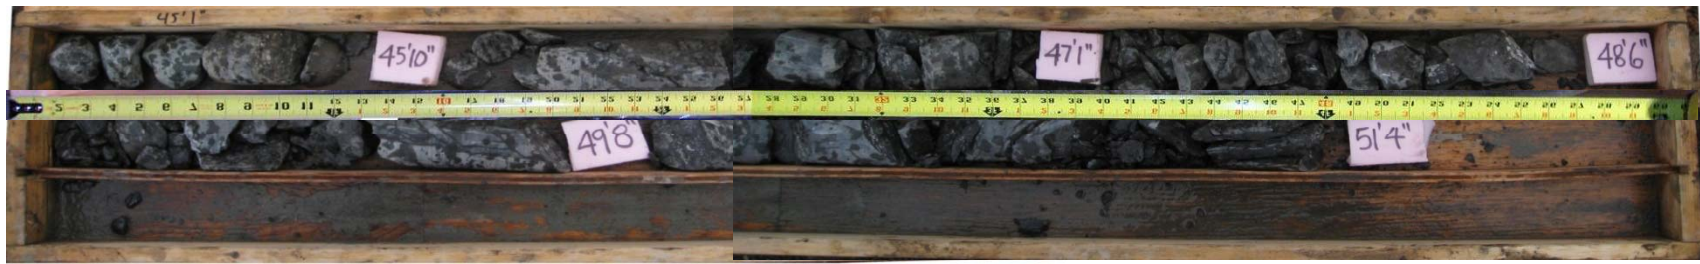
BH09-04 – Box 1 of 1: 12.3 m to 15.7 m (40'6" to 51'4")

Sedimentary bedrock was encountered in one borehole drilled within Slack Point (BH09-04) at a depth of about 12.2 m (elevation -8.9 m). The rock consisted of highly fractured, moderately weathered mudstone (argillite). An attempt was made to carry out a point load test on a sample of this material; however, due to the highly fractured state of the material, it was not possible to get a suitable representative sample of intact rock to test. As such, its strength could not be accurately measured.

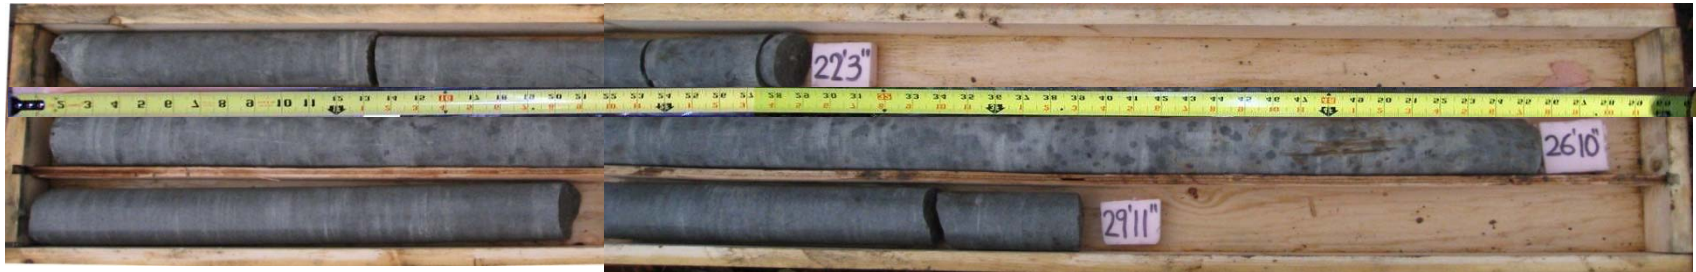
BH10-06 – Box 1 of 1: 5.6 m to 9.1 m (18'5" to 29'11")

Borehole BH09-06, drilled at the south end of the Uplands area as part of the geotechnical investigation, encountered bedrock at about 5.6 m below the existing ground surface. Upon encountering bedrock, HQ diamond coring was carried out to a depth of approximately 3.5 m into the rock layer. The core was transported to our Burnaby warehouse for more detailed classification and logging. Inspection of the rock indicated that it comprises a fresh, massive, light grey, fine-grained sandstone. A Uniaxial Compressive Strength (UCS) test was conducted on a sample of the rock. The results indicate that the rock sample had a strength of approximately 103 MPa. Point load tests were conducted on 7 specimens obtained from the rock core. The results indicate that the UCS of the sandstone ranges from about 48 MPa to 120 MPa; however, all but one test ranged from about 86 MPa to 120 MPa. The Rock Strength Category of the rock (Modified from ISRM, 1981) ranges from R3 to R5, but was typically R4 to R5, indicating strong to very strong rock.
