REMEDIAL COSTS FOR LADYSMITH HARBOUR

Ladysmith, BC

Report Number: 0914365008-500-R-Rev1

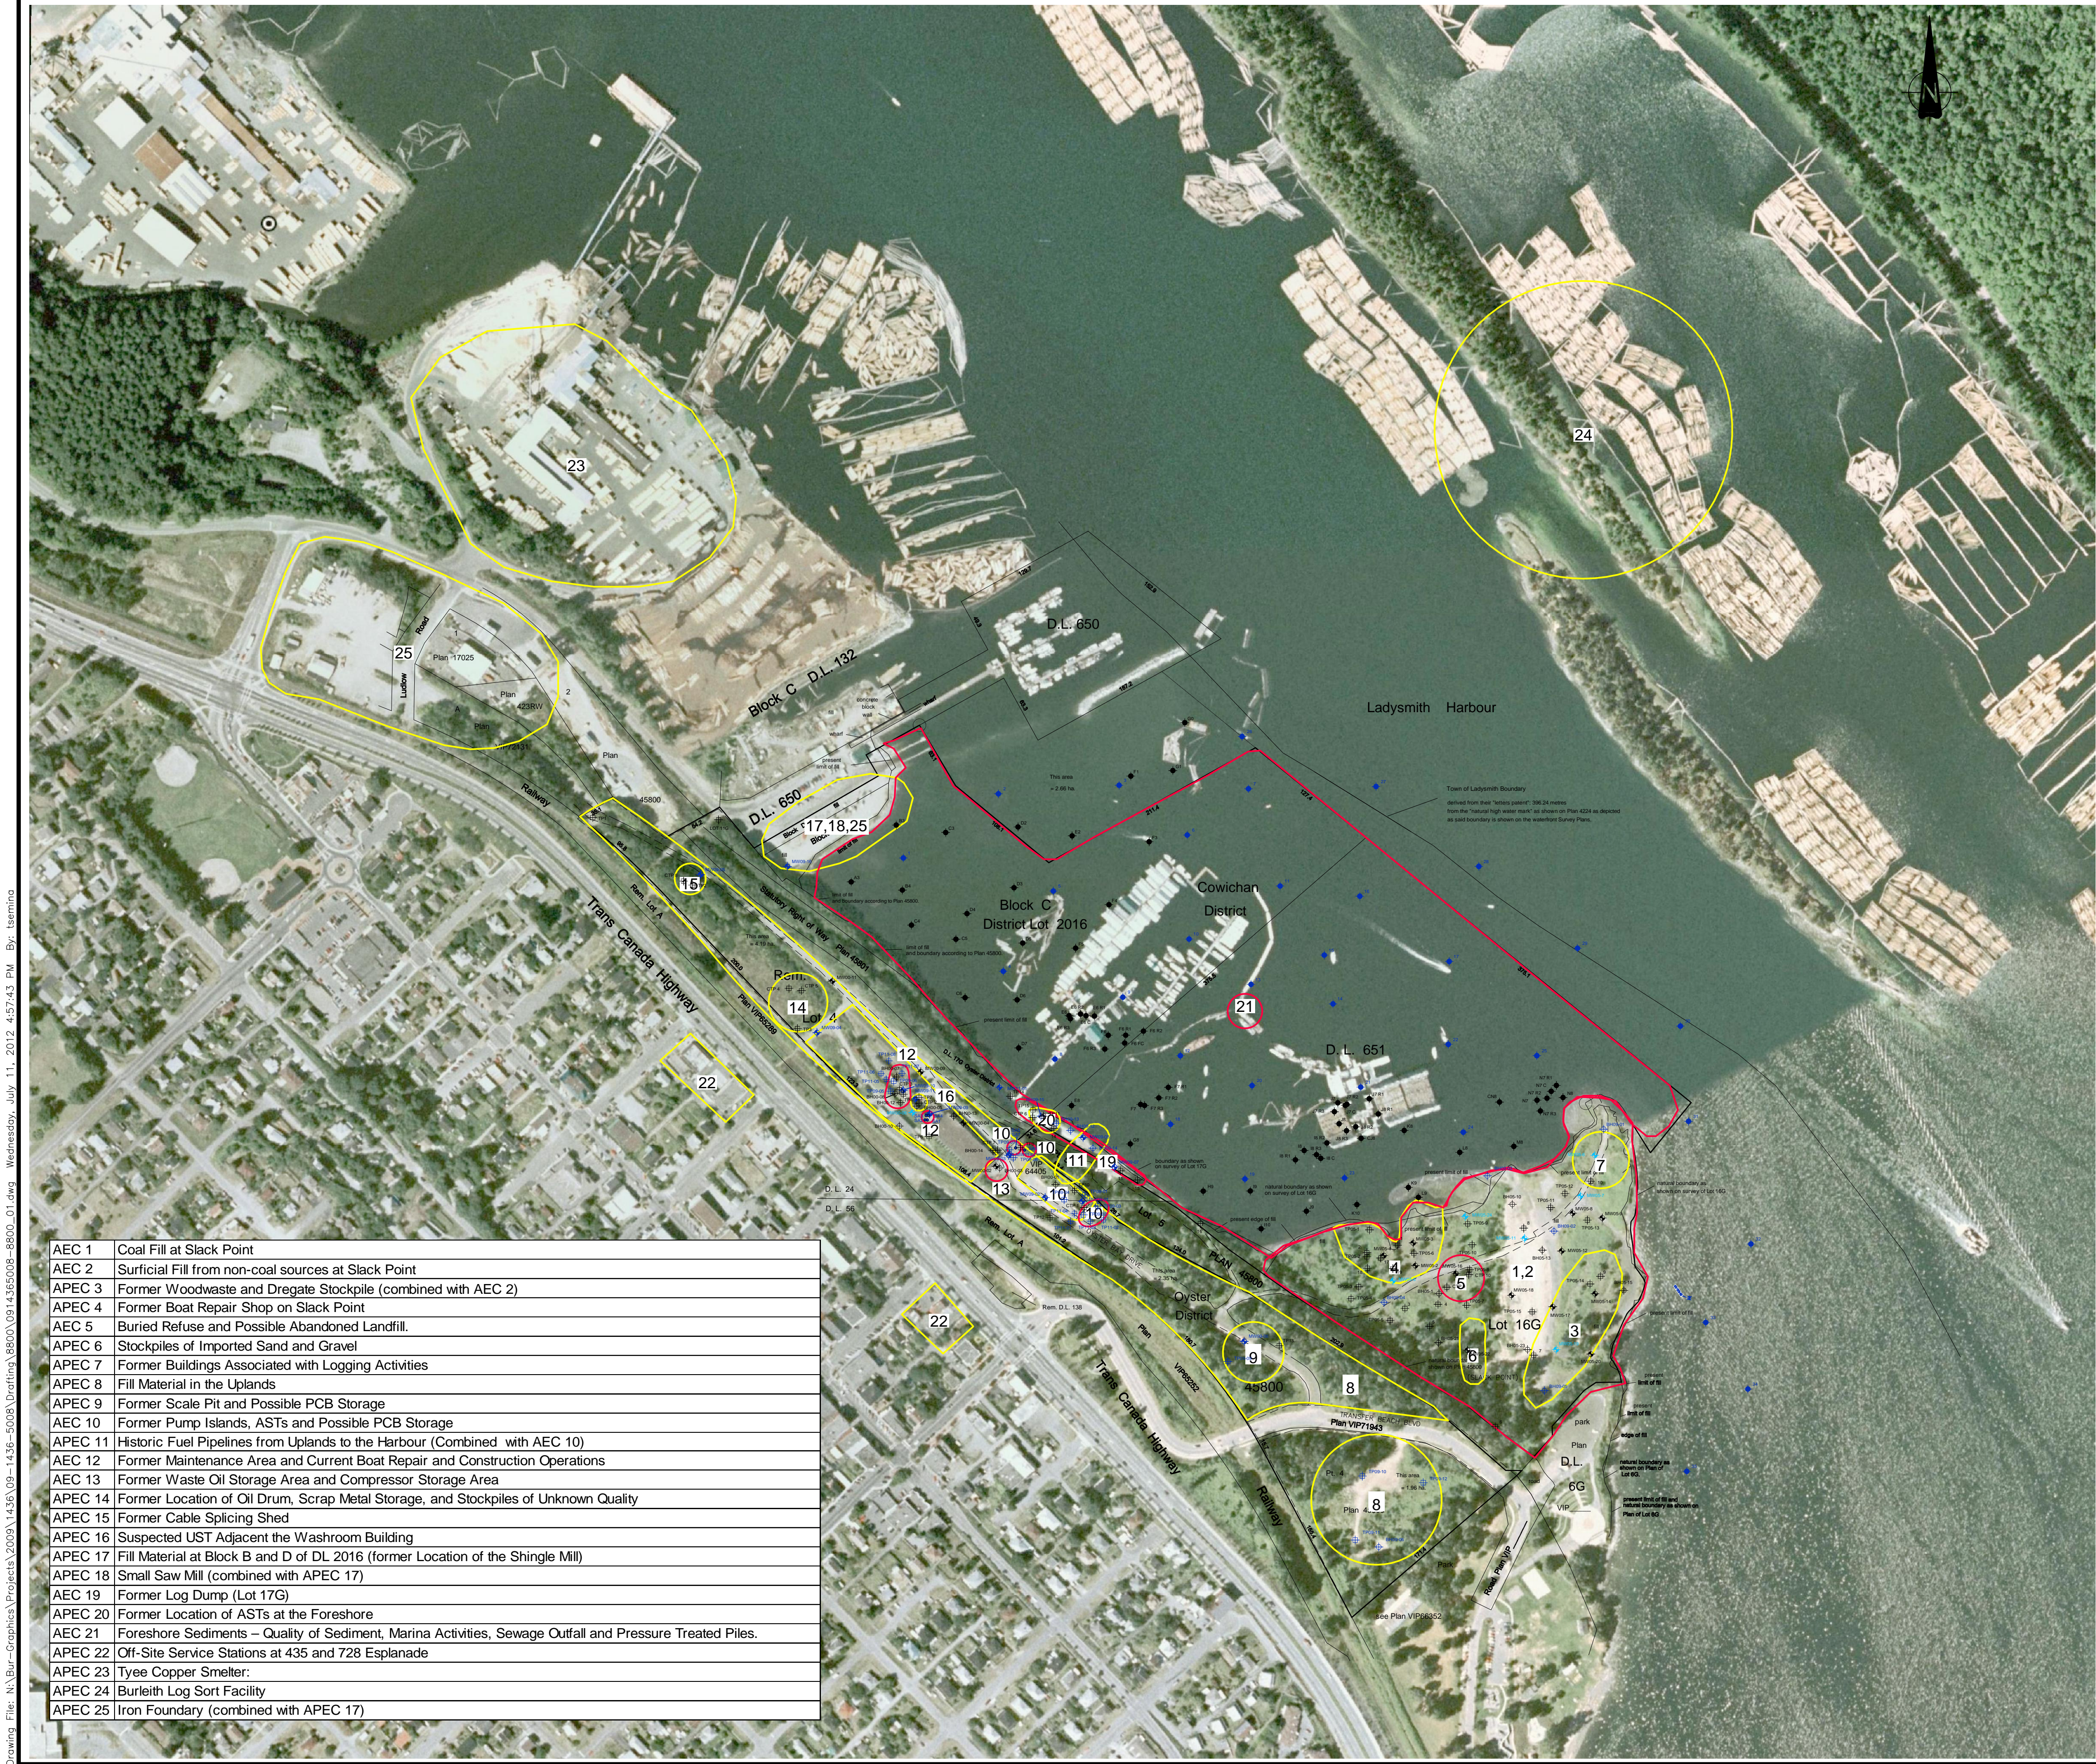
LOCATIONS OF AECs

AEC 1	Coal Fill at Slack Point
AEC 2	Surficial Fill from non-coal sources at Slack Point
APEC 3	Former Woodwaste and Dregate Stockpile (combined with AEC 2)
APEC 4	Former Boat Repair Shop on Slack Point
AEC 5	Buried Refuse and Possible Abandoned Landfill.
APEC 6	Stockpiles of Imported Sand and Gravel
APEC 7	Former Buildings Associated with Logging Activities
APEC 8	Fill Material in the Uplands
APEC 9	Former Scale Pit and Possible PCB Storage
AEC 10	Former Pump Islands, ASTs and Possible PCB Storage
APEC 11	Historic Fuel Pipelines from Uplands to the Harbour (Combined with AEC 10)
AEC 12	Former Maintenance Area and Current Boat Repair and Construction Operations
AEC 13	Former Waste Oil Storage Area and Compressor Storage Area
APEC 14	Former Location of Oil Drum, Scrap Metal Storage, and Stockpiles of Unknown Quality
APEC 15	Former Cable Splicing Shed
APEC 16	Suspected UST Adjacent the Washroom Building
APEC 17	Fill Material at Block B and D of DL 2016 (former Location of the Shingle Mill)

APEC 18	Small Saw Mill (combined with APEC 17)
AEC 19	Former Log Dump (Lot 17G)
APEC 20	Former Location of ASTs at the Foreshore
AEC 21	Foreshore Sediments – Quality of Sediment, Marina Activities, Sewage Outfall and Pressure Treated Piles.
APEC 22	Off-Site Service Stations at 435 and 728 Esplanade
APEC 23	Tyee Copper Smelter:
APEC 24	Burleith Log Sort Facility
APEC 25	Iron Foundry (combined with APEC 17)

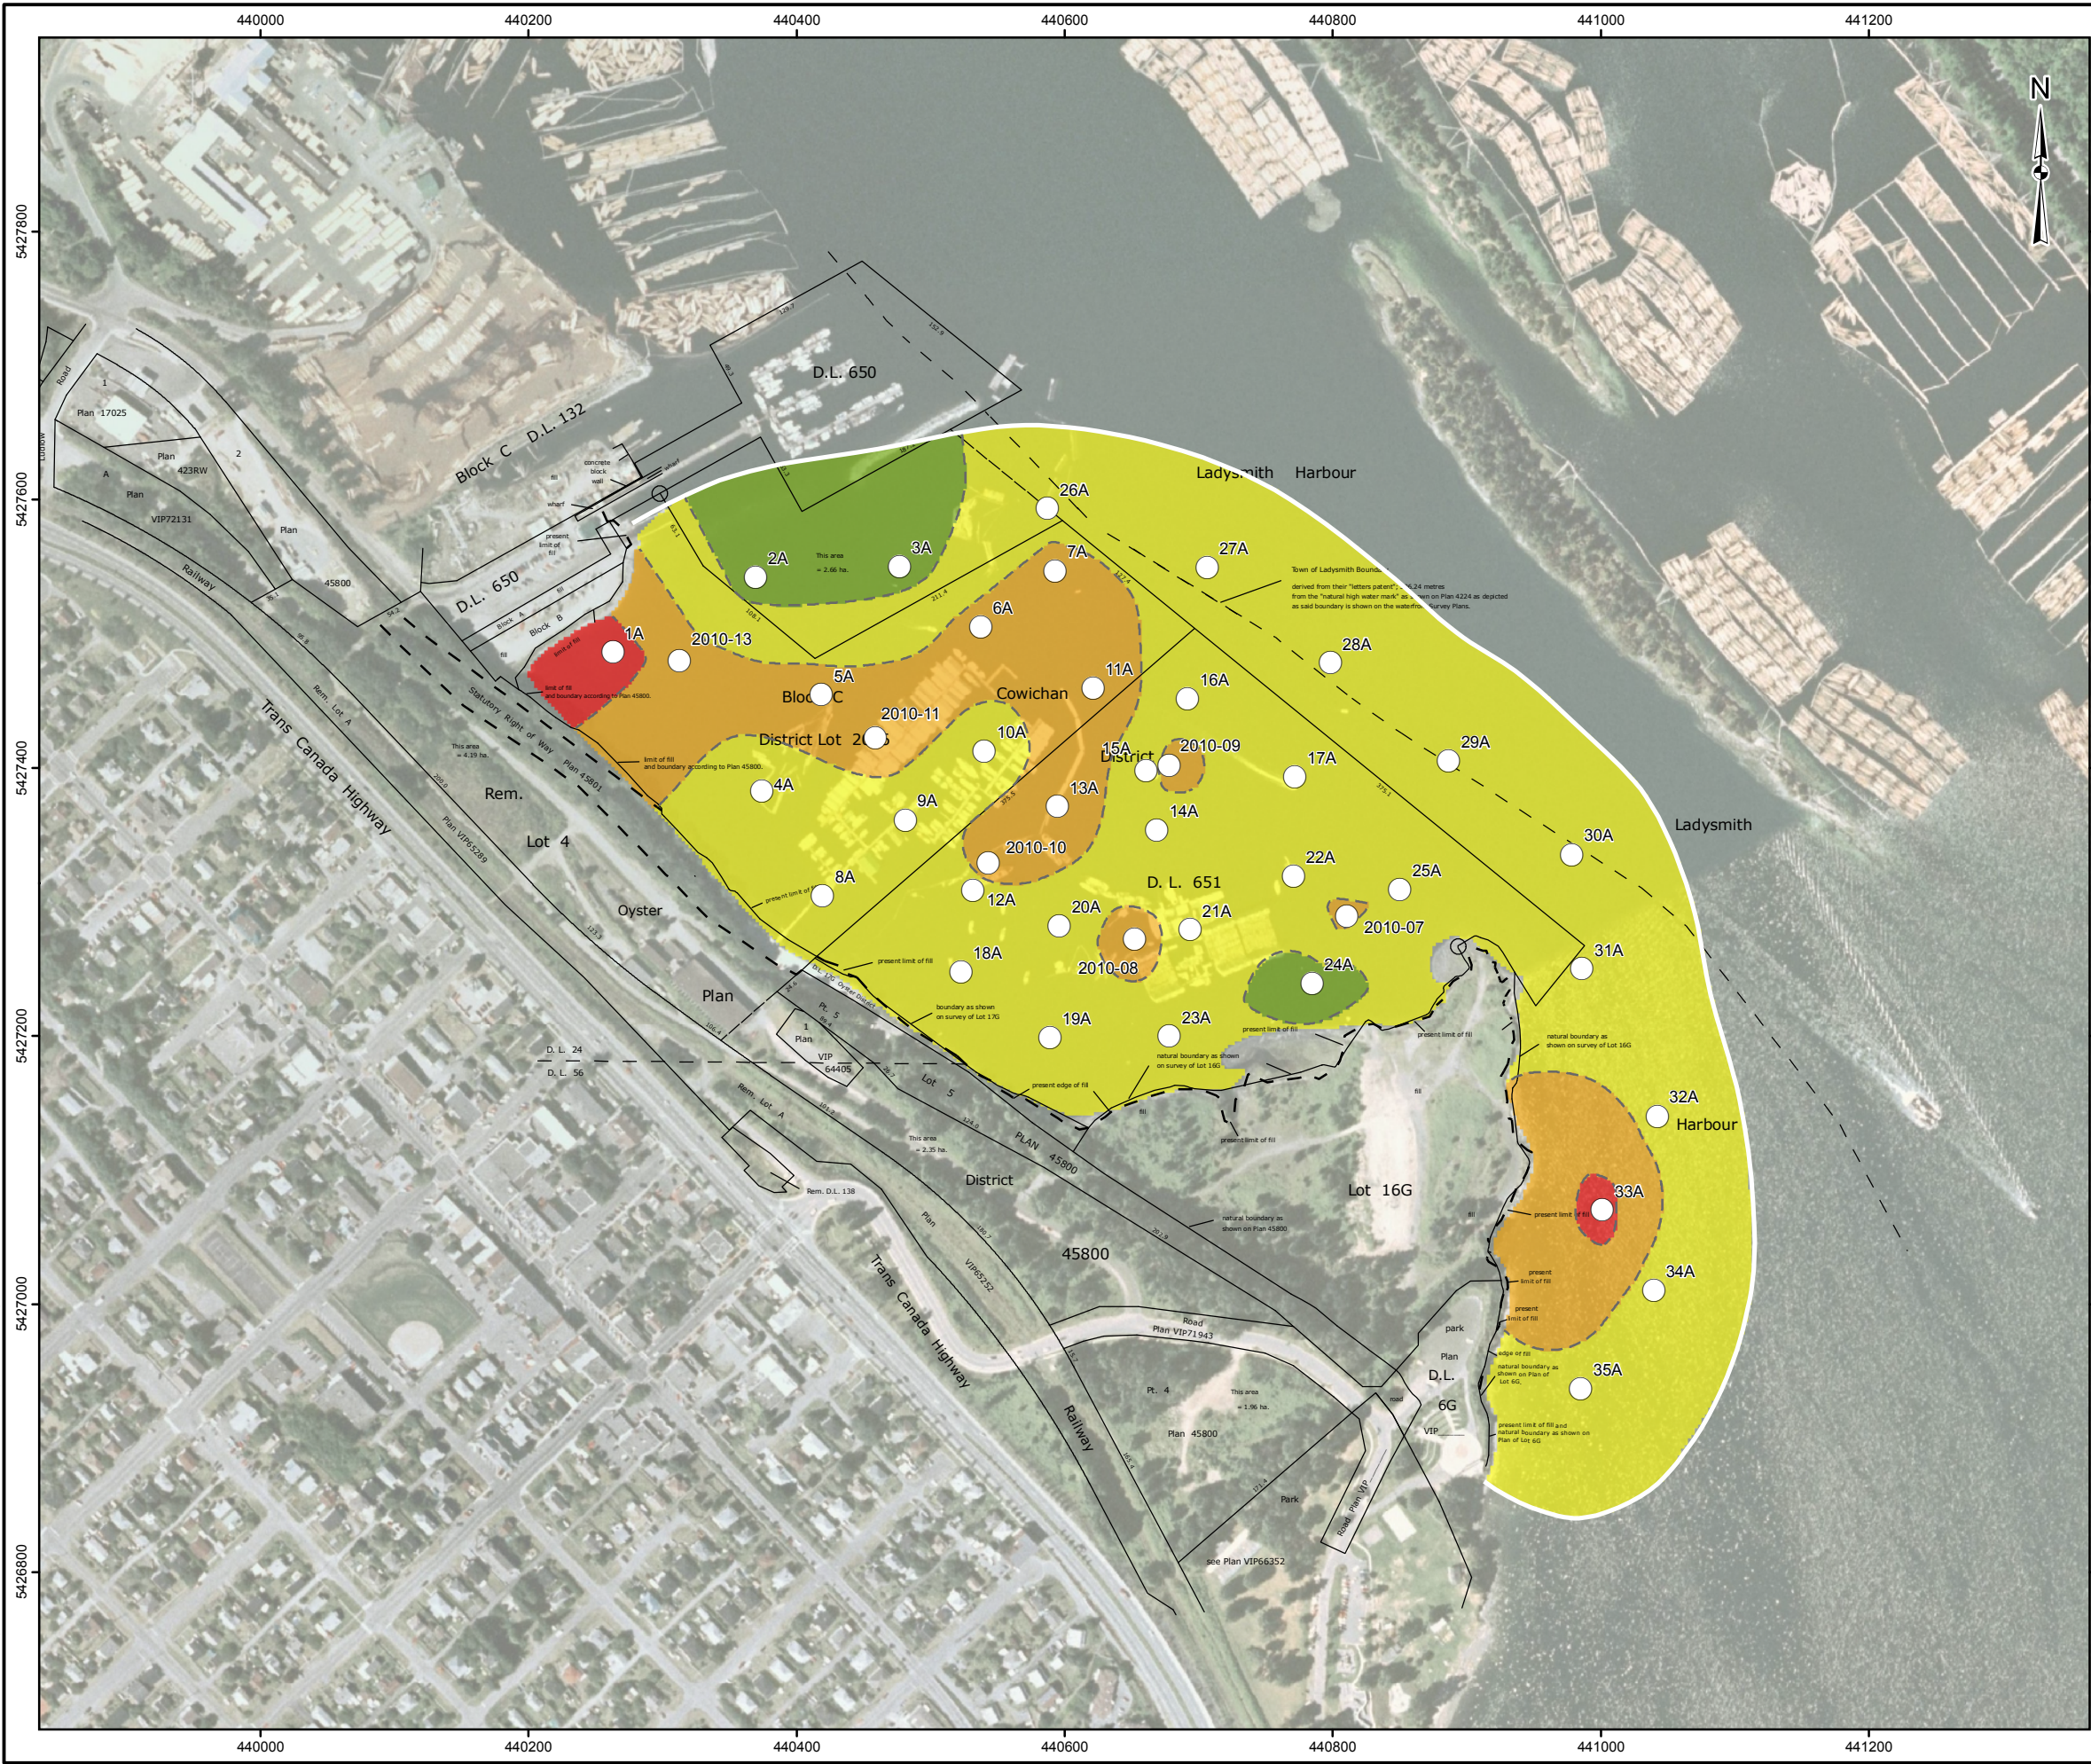
- **Category 1:** Small portions of the harbour west of Slack Point and in the northwest corner of the harbour can be categorized as having conditions favourable for Disposal at Sea, with low uncertainty;

- **Category 2:** More than half of the harbour can be categorized as having conditions favourable for Disposal at Sea, but uncertainty was considered high due to data gaps regarding sediment toxicity;

- **Category 3:** Less than half of the harbour was categorized as having conditions potentially unfavourable for Disposal at Sea. Over much of this area uncertainty was considered high due to data gaps regarding contaminant bioavailability and sediment toxicity; and

- **Category 4:** In the westernmost corner of the harbour and in an area on the east side of Slack Point, conditions were considered unfavourable and uncertainty was low because observed toxicity to amphipods provides an indication that sediments are likely to fail Disposal at Sea approval guidelines.
