2014

Annual Water Report

Prepared by: Town of Ladysmith Infrastructure Services Department

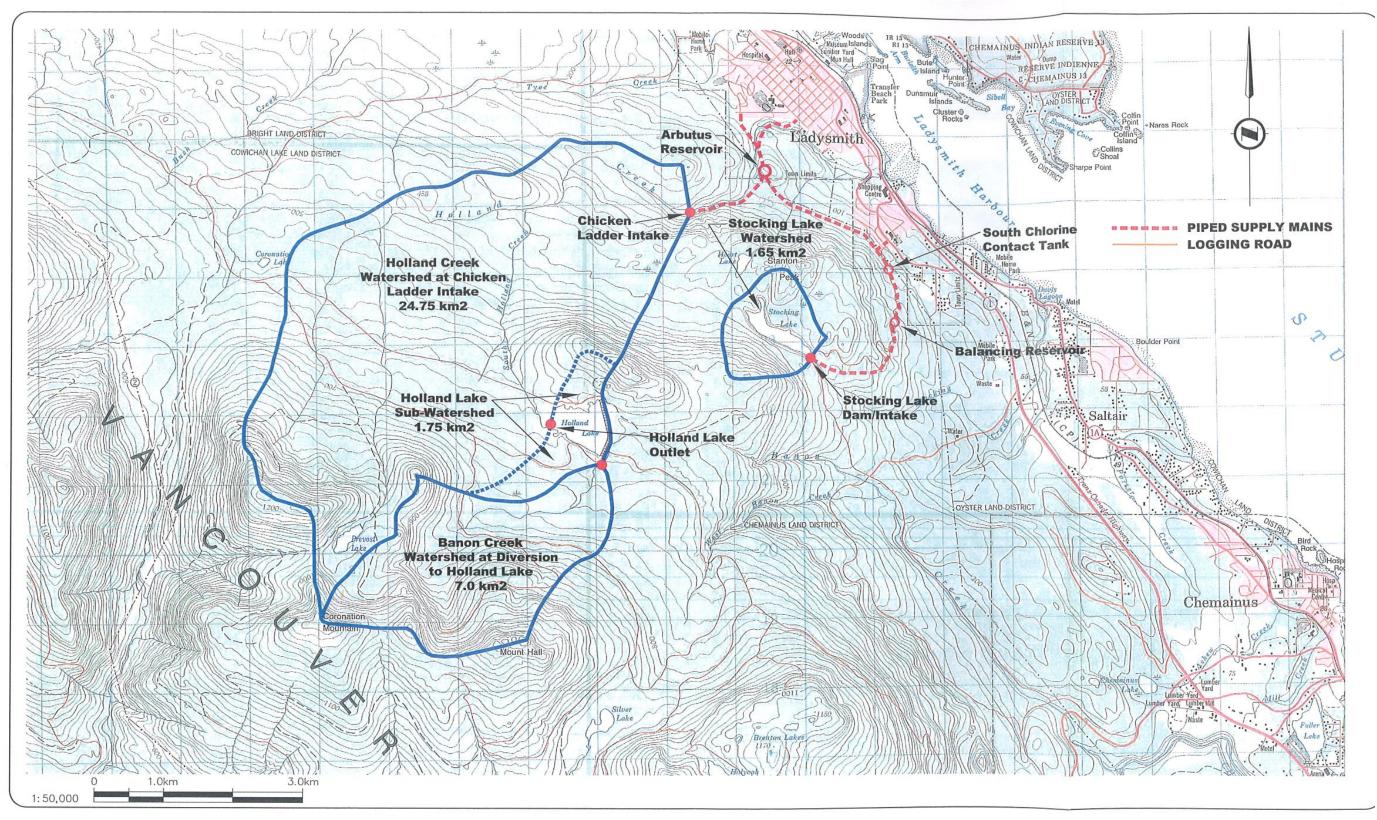
Figure 1 System Overview

Figure one shows the general layout of the Watersheds and major storage and intake structures.

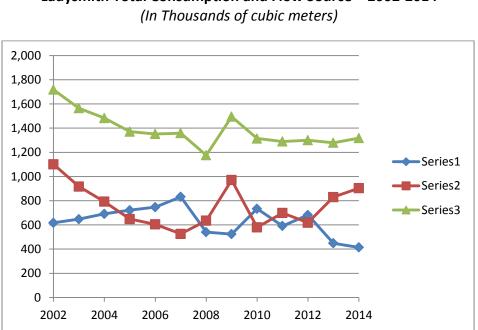
The Town used 1,317,000 cubic meters of water in 2014, an increase of 2.0% over 2013., but still considerably less than the consumption in 2002 (1.7M cu m). This reflects a trend that has been occurring at the Town since residential water metering was introduced in 2006. The Town is using approximately 25% less water now than 11 years ago (2002 annual consumption was 1,700,000 cu m). During the same period, the Town has grown over 20%, resulting in a net reduction of per capita water consumption in the order of 45%.

A summary of water consumption by month, including the flow splits between Stocking Lake and Chicken Ladder Intake (Holland Creek) follows on the next page, and is illustrated as follows:

The general downward trend in water consumption is likely the result of the Town's decision to install residential water meters in 2006, as well as its progressive block pricing rate structure for single family residential water accounts. The Town has also been encouraging water conservation through programs such as a toilet rebate program, which would also have a downward impact on consumption.
