2017

Annual Water Report

Prepared by: Town of Ladysmith Infrastructure Services Department

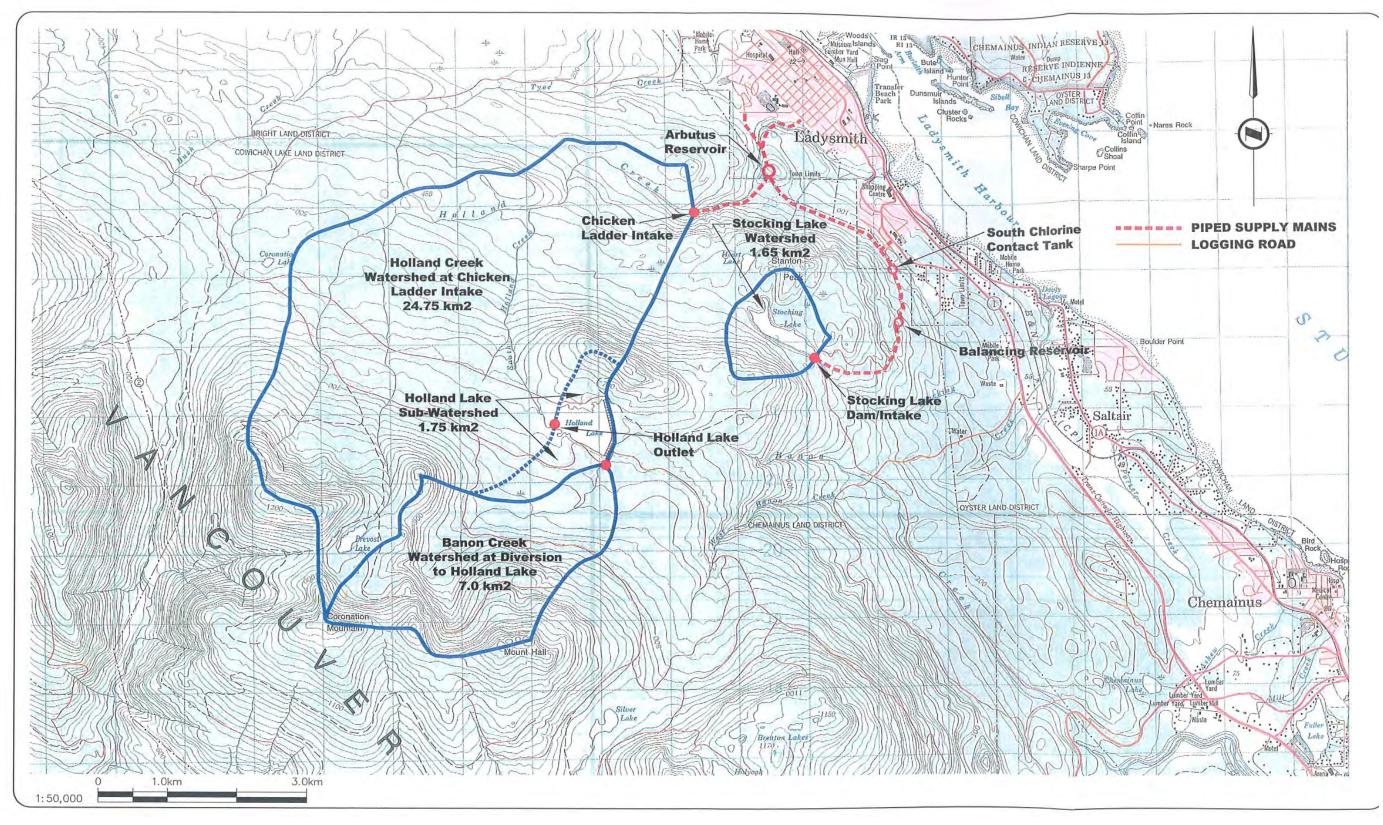
Figure 1 System Overview

Figure 1 shows the general layout of the Watersheds and major storage and intake structures.

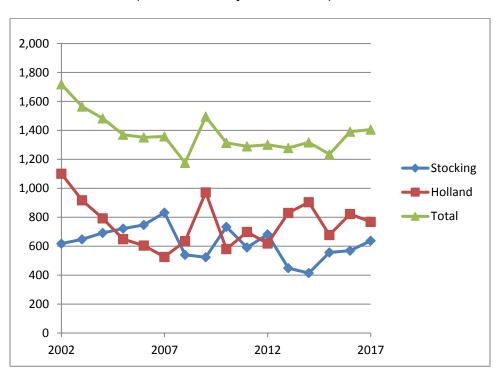
The Town used 1,405,334 cubic meters of water in 2017, a increase of 1% over 2016, and considerably less than the consumption in 2002 (1.7M cu m). This reflects a trend that has been occurring at the Town since the introduction of residential water metering in 2006. The Town is using approximately 17% less water now than 15 years ago (2002 annual consumption was 1,700,000 cu m). During the same period, the Town has grown over 24.6%, resulting in a net reduction of per capita water consumption in the order of 36%.

A summary of water consumption by month, including the flow splits between Stocking Lake and Chicken Ladder Intake (Holland Creek) follows on the next page, illustrated as follows:

The general downward trend in water consumption is likely the result of the Town's decision to install residential water meters in 2006, as well as its progressive block pricing rate structure for single family residential water accounts. The Town has also been encouraging water conservation through programs such as a toilet rebate program, which would also have a downward impact on consumption.
