Overview-Level Geotechnical Investigation and Assessment Ladysmith Harbour Ladysmith, BC

Ministry of Forests, Lands and Natural Resource
Operations
Crown Land Opportunities and Restoration Branch
4th Floor, 780 Blanshard Street
Victoria, BC
V8W 2H1

Report Number: 09-1436-5008/6000

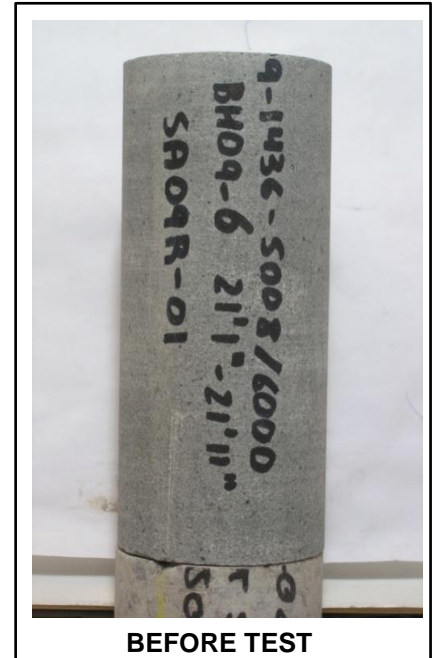
Project No.: 09-1436-5008/6000	Borehole: BH09-6
Project: Ladysmith Harbour	Sample Number: 1
Location: 0	Depth (m): 21'1"-21'11"
Client: 0	Lab ID No: 230

Testing Results	Sample Measurements
Max Load (kN) <u>297.70</u>	Diameter (mm) <u>60.57</u>
Stress σ (MPa) <u>103.32</u>	Height (mm) <u>122.40</u>
Pace Rate (kN/s) <u>0.50</u>	Area (cm ²) <u>28.81</u>
Lithology <u>-</u>	Volume (cm ³) <u>352.68</u>
	Mass (g) <u>880.60</u>
	Moisture Content (%) <u>0.06</u>
	Wet Density (Kg/m ³) <u>2496.85</u>
	Dry Density (Kg/m ³) <u>2495.29</u>

Failure Mode	Notes
Type: <u>3</u>	- Water content as received Mode:
Degrees:* _____	(1) Single diagonal shear plane
	(2) Vertical fracture(s)
	(3) Vertical splitting
	(4) Shear along foliation /discontinuity
	(5) Conical
* Degrees measured with respect to core axis.	(6) Spalling
	(7) Other
