Request for Qualifications

No. 2024-IS-05

**Holland Creek (Mackie Rd) Dam D720190
Decommissioning Contractor**

Holland Creek – Mackie Road Dam (D720190) Preliminary Decommissioning Report

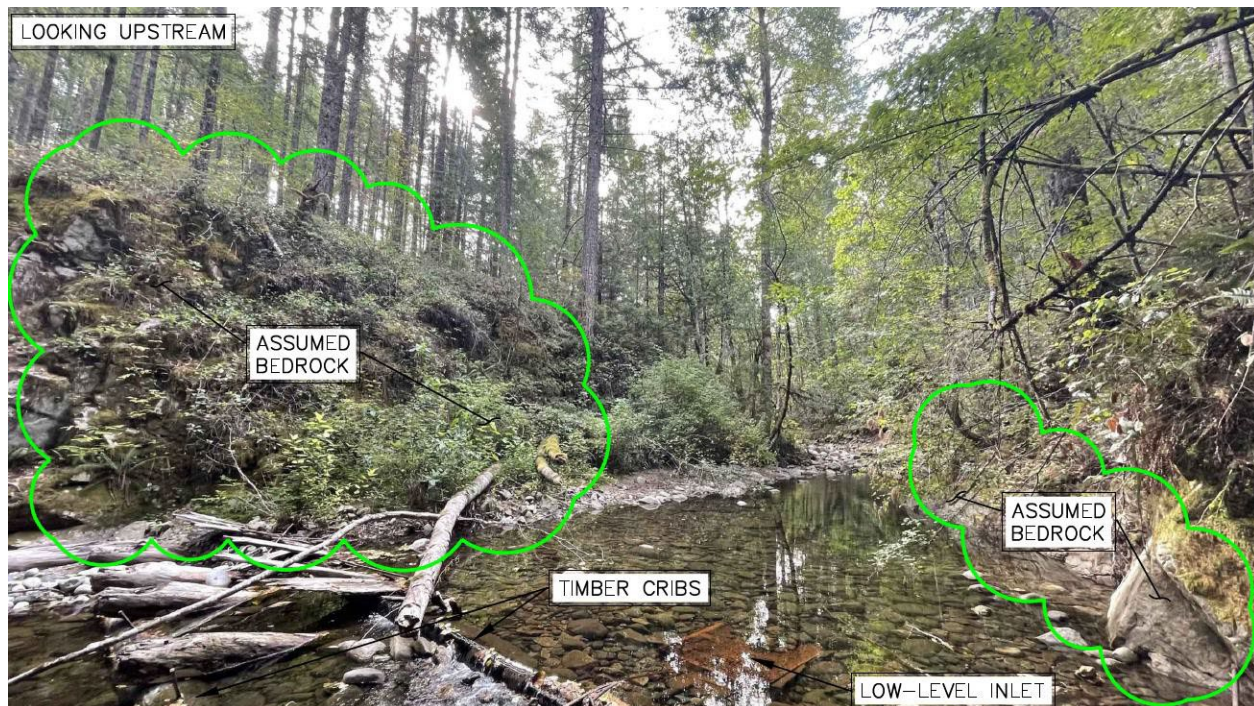
Figure 4.1 U/S Bedrock Identification & Visualization

Three separate scenarios are assumed based off of most likely bedrock profiles/sections, and the bedrock will govern the profile and section of the channel if/when it is exposed. The bedrock profile was assumed based on the conditions at time of the DSI's site inspection and survey; this is illustrated in Figure 4.1 & Figure 4.2 for visualization.

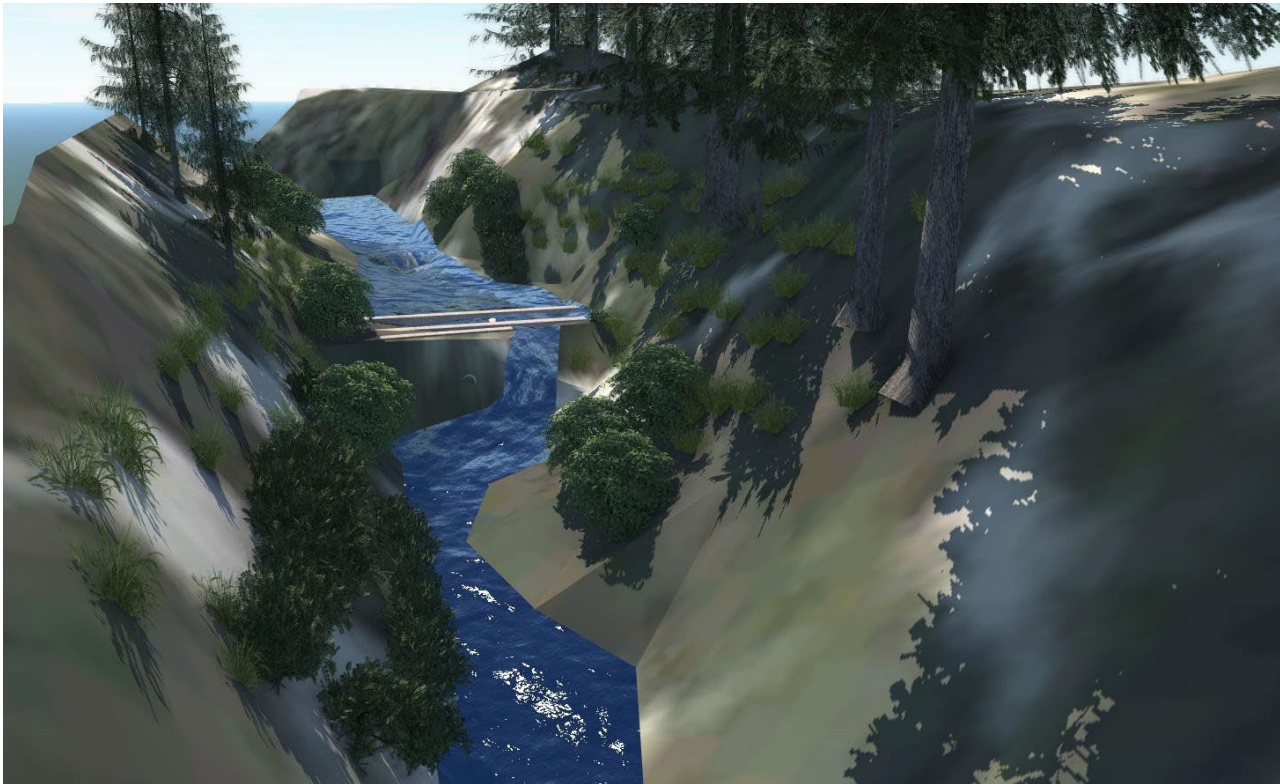
Figure 4.3 **Mackie Rd Dam Existing 3D model**

Based off of the most probable bedrock scenarios, three conceptual designs were produced to illustrate the decommissioning. These can be seen in a preliminary drawing package, Appendix D. The most likely design is scenario 2, this is illustrated in a snapshot from a conceptual 3D model produced in AutoCAD InfraWorks, Figure 4.3 & 4.4.

1. A proposed layout for the deconstruction of Mackie Road Dam is to temporarily re-route the water along the right side of the channel. The right side of the channel was chosen due to less shallow bedrock present. This will be achieved by removing a portion of the dam face and excavating a small channel following the right bank. The channel dimensions and specifications will be determined in the detailed design. The water will be re-routed through this channel leaving the left side of the channel dry. As part of the dewatering process, an attempt to reinstate the LLO could be considered in the discharge of additional flow. The impounded sediment/river rock on the dry portion will be excavated to reveal subsurface conditions and graded back to the point detailed in the design drawings, uncovering the timber cribs. The temporary diversion should be excavated further in a phased approach relative to the sediment excavation which should be uniform; this ensures the left portion remains dry, and the water remains in the temporary diversion. As the impounded sediment is removed offsite, the dam crest may be removed at the same rate as the sediment removal. If shallow bedrock is encountered during excavation, the temporary diversion method may need to be modified with the use of sandbags, tiger dam or barrel and pipe etc. to maintain this temporary diversion. See structural removal plan and Figure 4.3.a for more details and visualization.

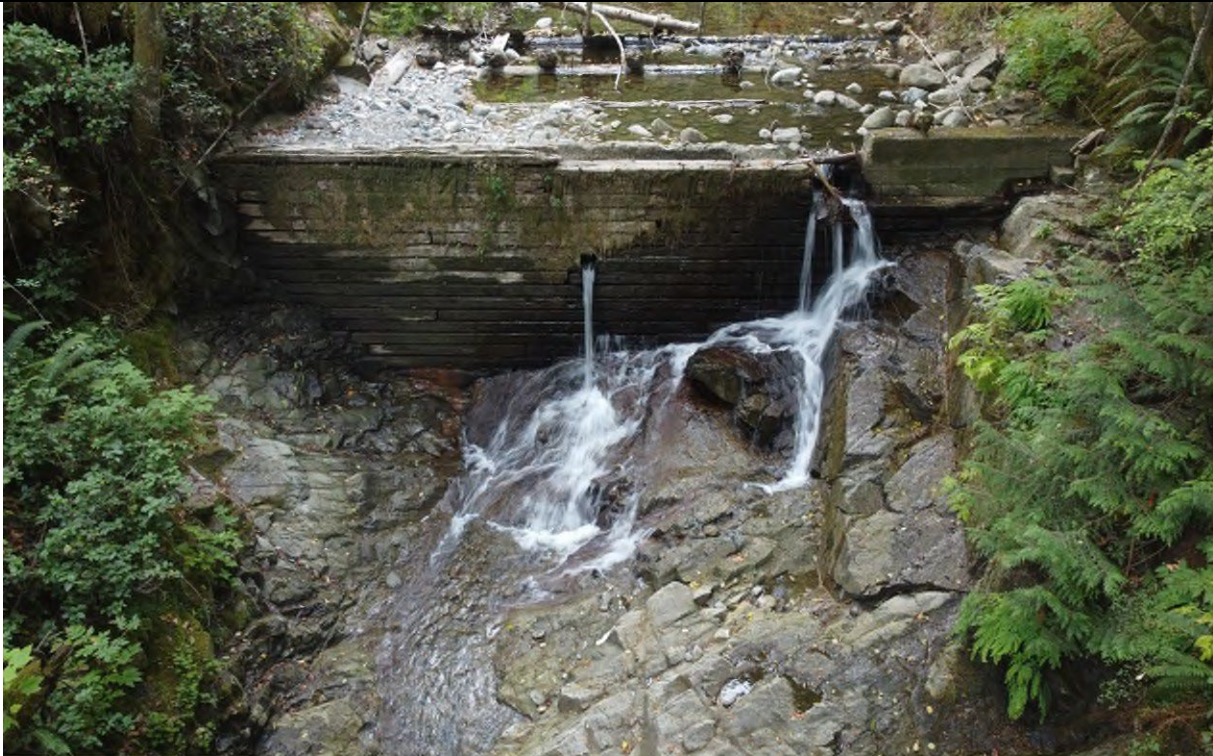
Photo No. 1	Date: 19 September 2023	Looking Towards: West	Location: Mackie Road Dam
Description: Looking at Mackie Road Dam during the low flow period.

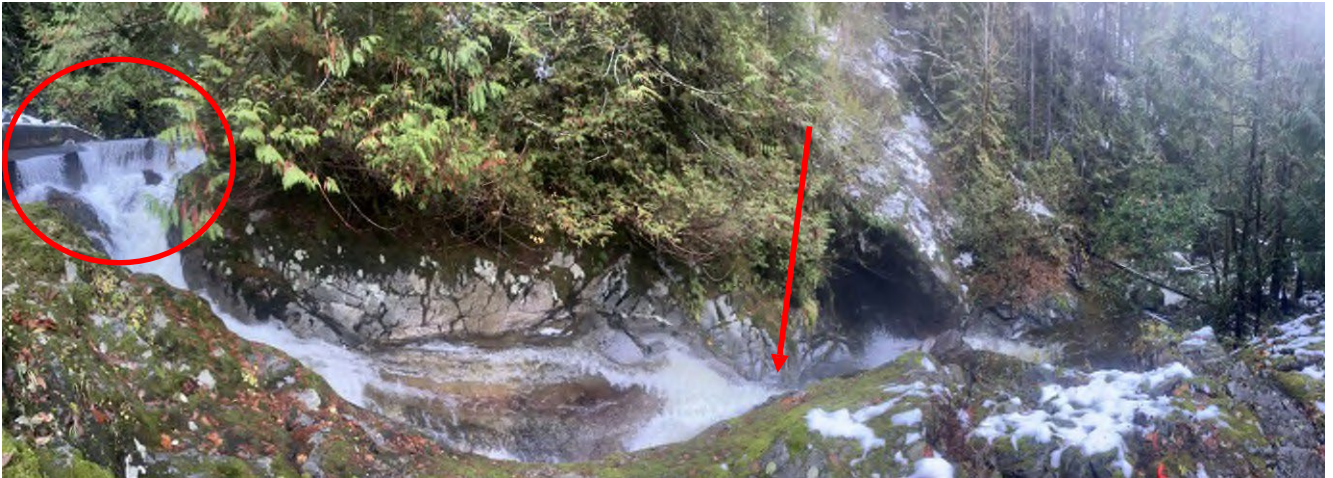
Description: Looking at the instream feature (i.e., fall, red arrow) located to the immediate downstream of Water Supply Dam (red circle) during the wet season.

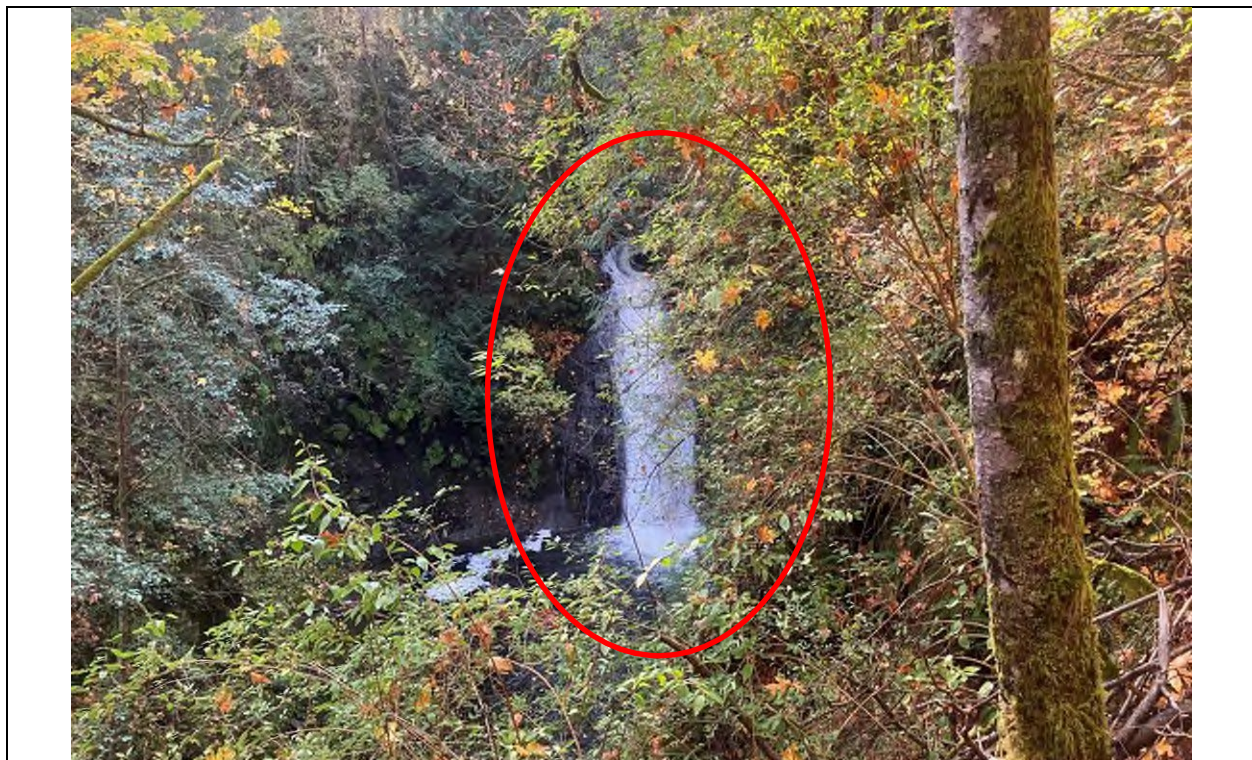
Description: Looking at the permanent fist barrier (i.e., waterfall, red oval) approximately 50 m downstream of Mackie Road Dam.

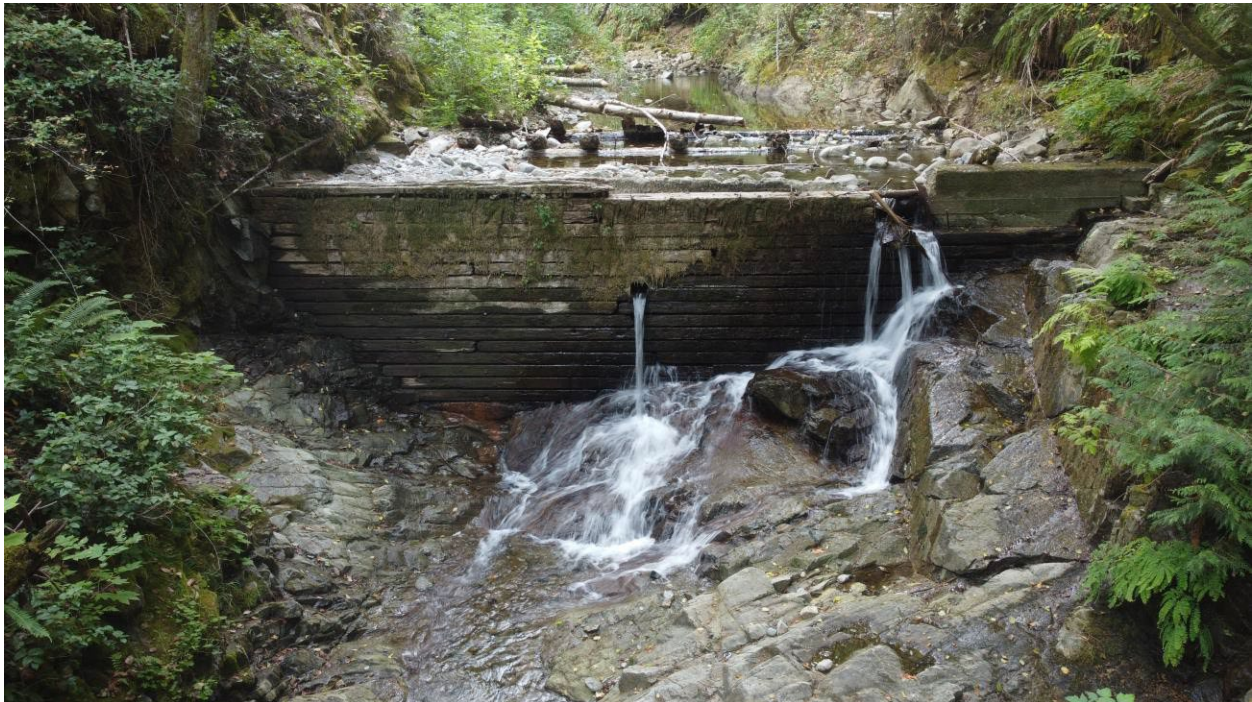
Photo 1 Downstream face of dam, looking southwest.

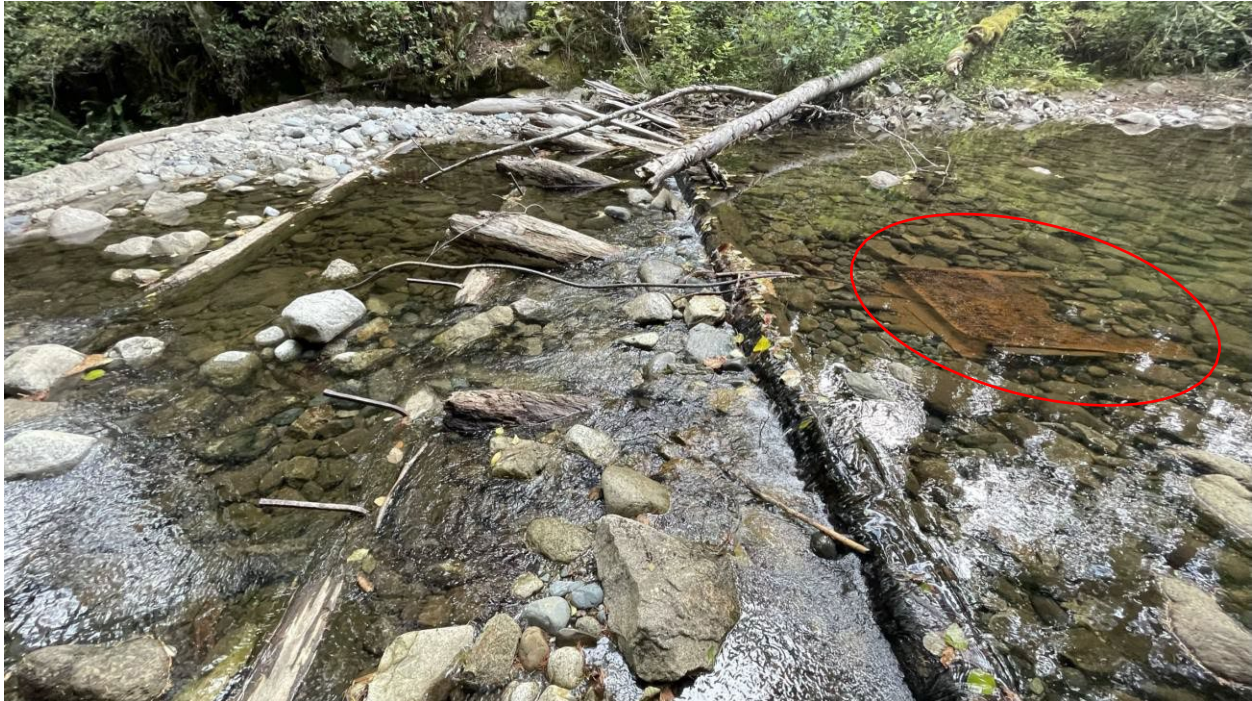
Photo 2 Low-Level metal intake grate and remnants of wooden flashboards, looking east (from left side of dam).

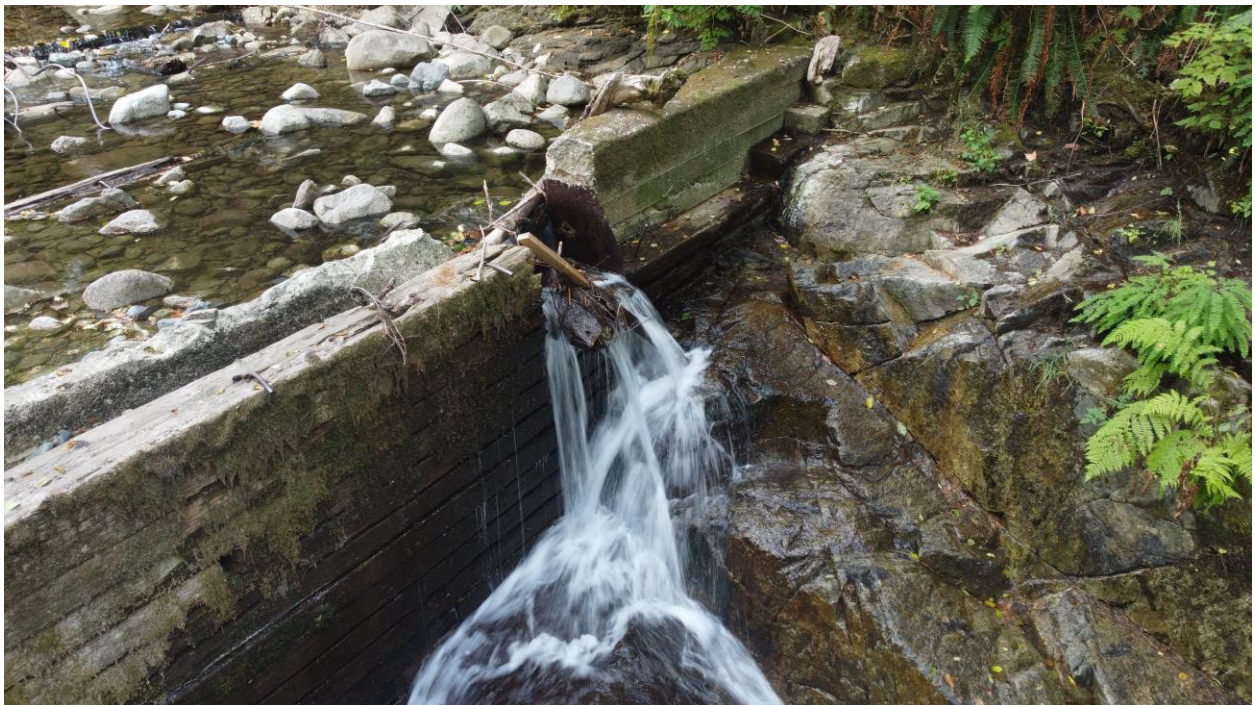
Photo 4 Control Structure on left side, view 1.

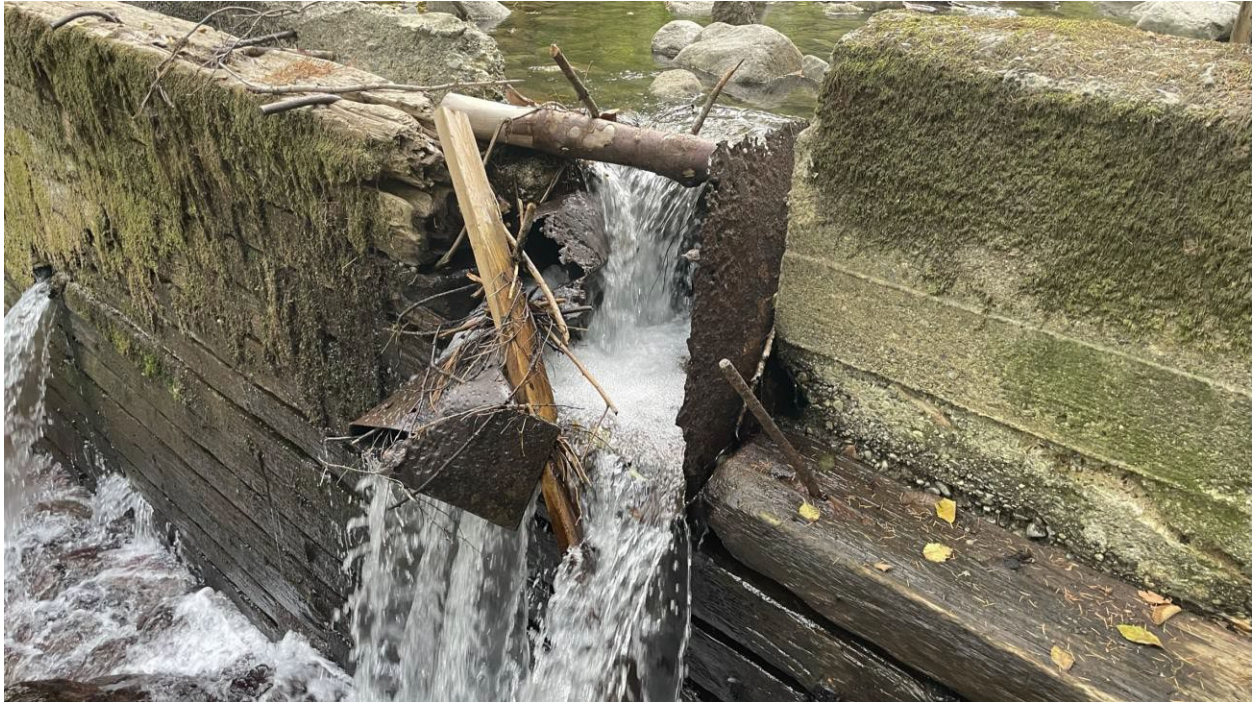
Photo 5 Control Structure on left side, view 2.

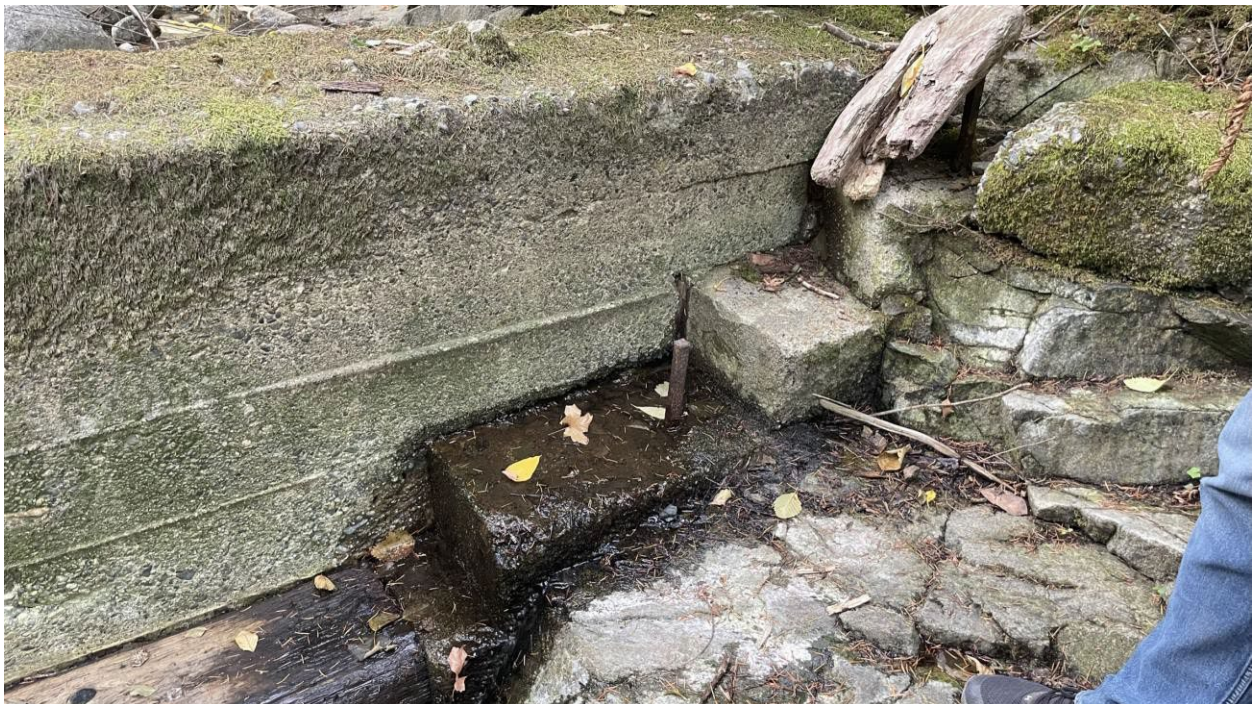
Photo 6 Seepage underneath left concrete abutment.

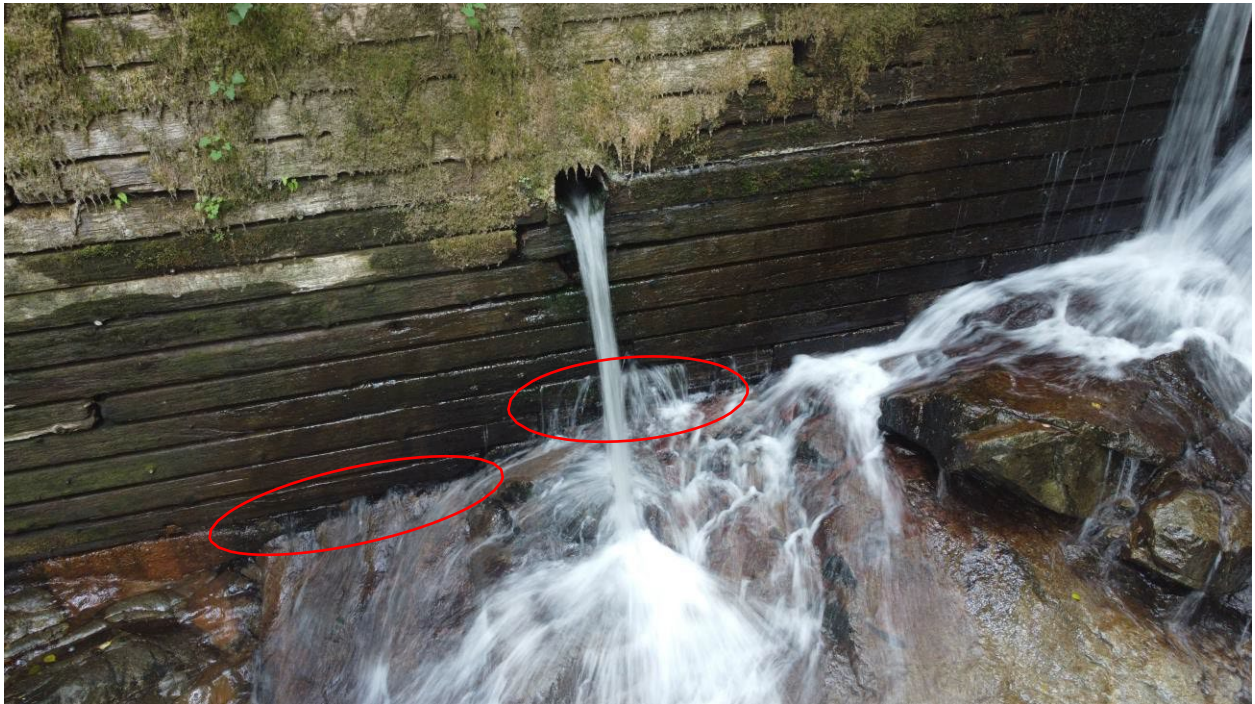
Photo 7 Major seepage at toe of downstream face.

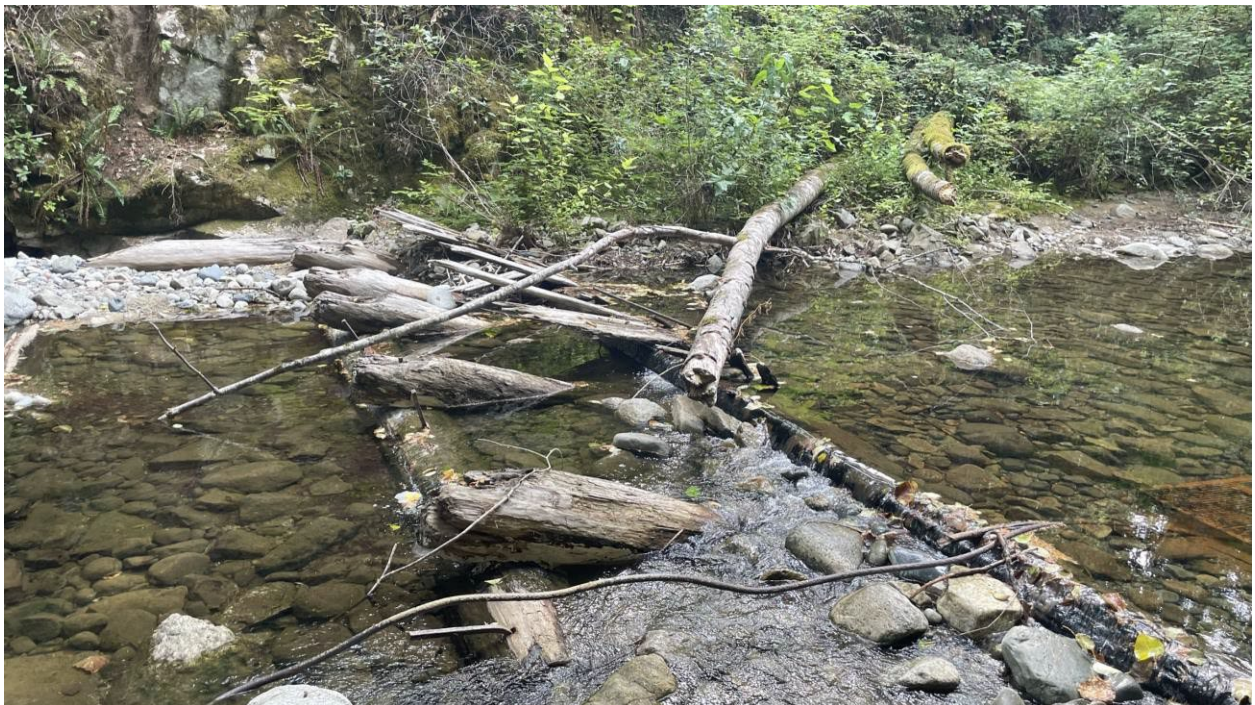
Photo 8 Vegetation built up on remnants of wooden flashboards on right side of upstream channel & miscellaneous debris.

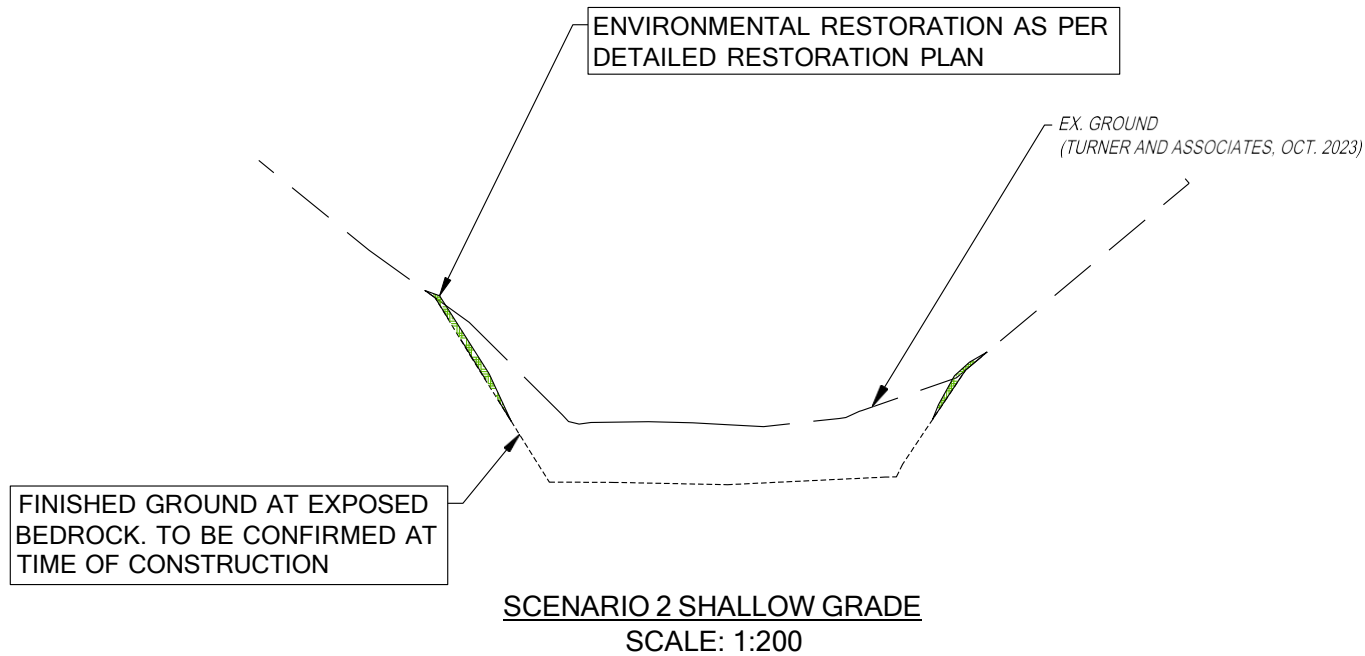
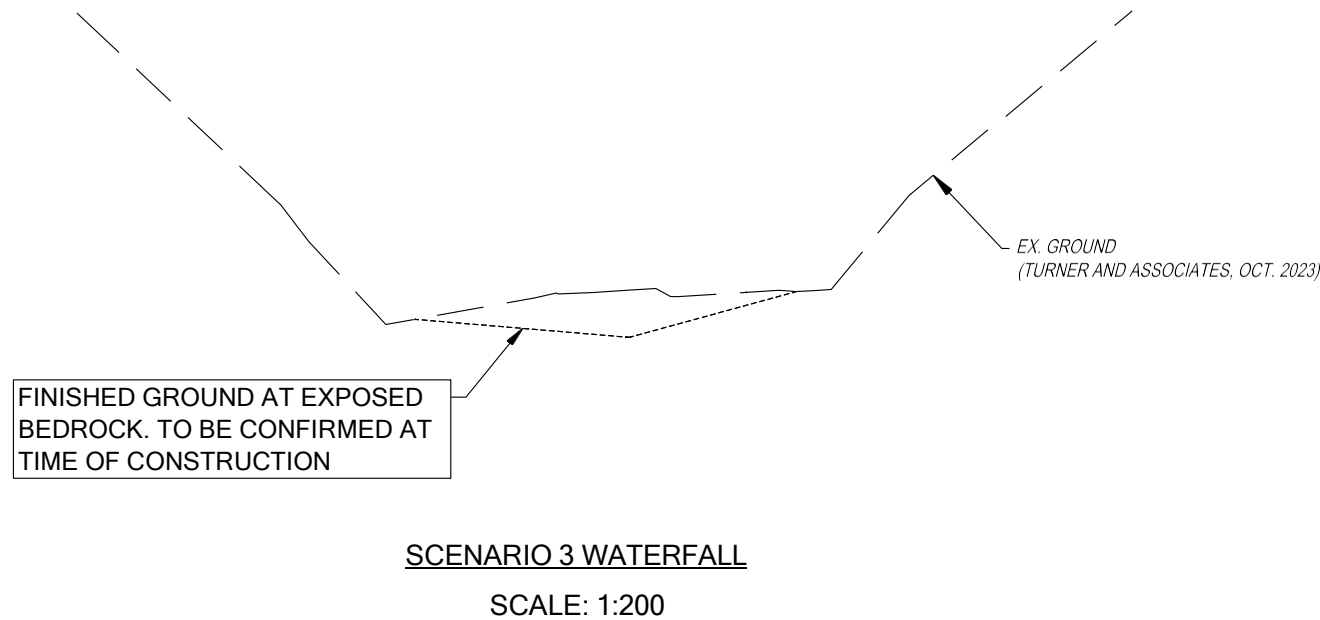
1. CHANNEL TO BE UNDERLAIN WITH GEOTEXTILE OR EROSION PREVENTION LAYER AS PER DETAILED SEDIMENT MANAGEMENT PLAN.
2. CHANNEL DEPTH, SIDE SLOPES AND PROFILE DEPENDANT ON BEDROCK CONDITIONS. ALL BEDROCK CONDITIONS ARE INFERRED FROM DOWNSTREAM SURVEYED SECTIONS & SITE CONDITIONS. TO BE CONFIRMED AT TIME OF CONSTRUCTION BY QUALIFIED GEOTECHNICAL ENGINEER. IF NO BEDROCK EXISTS ON SIDE SLOPES, MAXIMUM CHANNEL SIDE SLOPE SHOULD BE 2H:1V.
