2016

Annual Water Report

Town of Ladysmith

Infrastructure Services

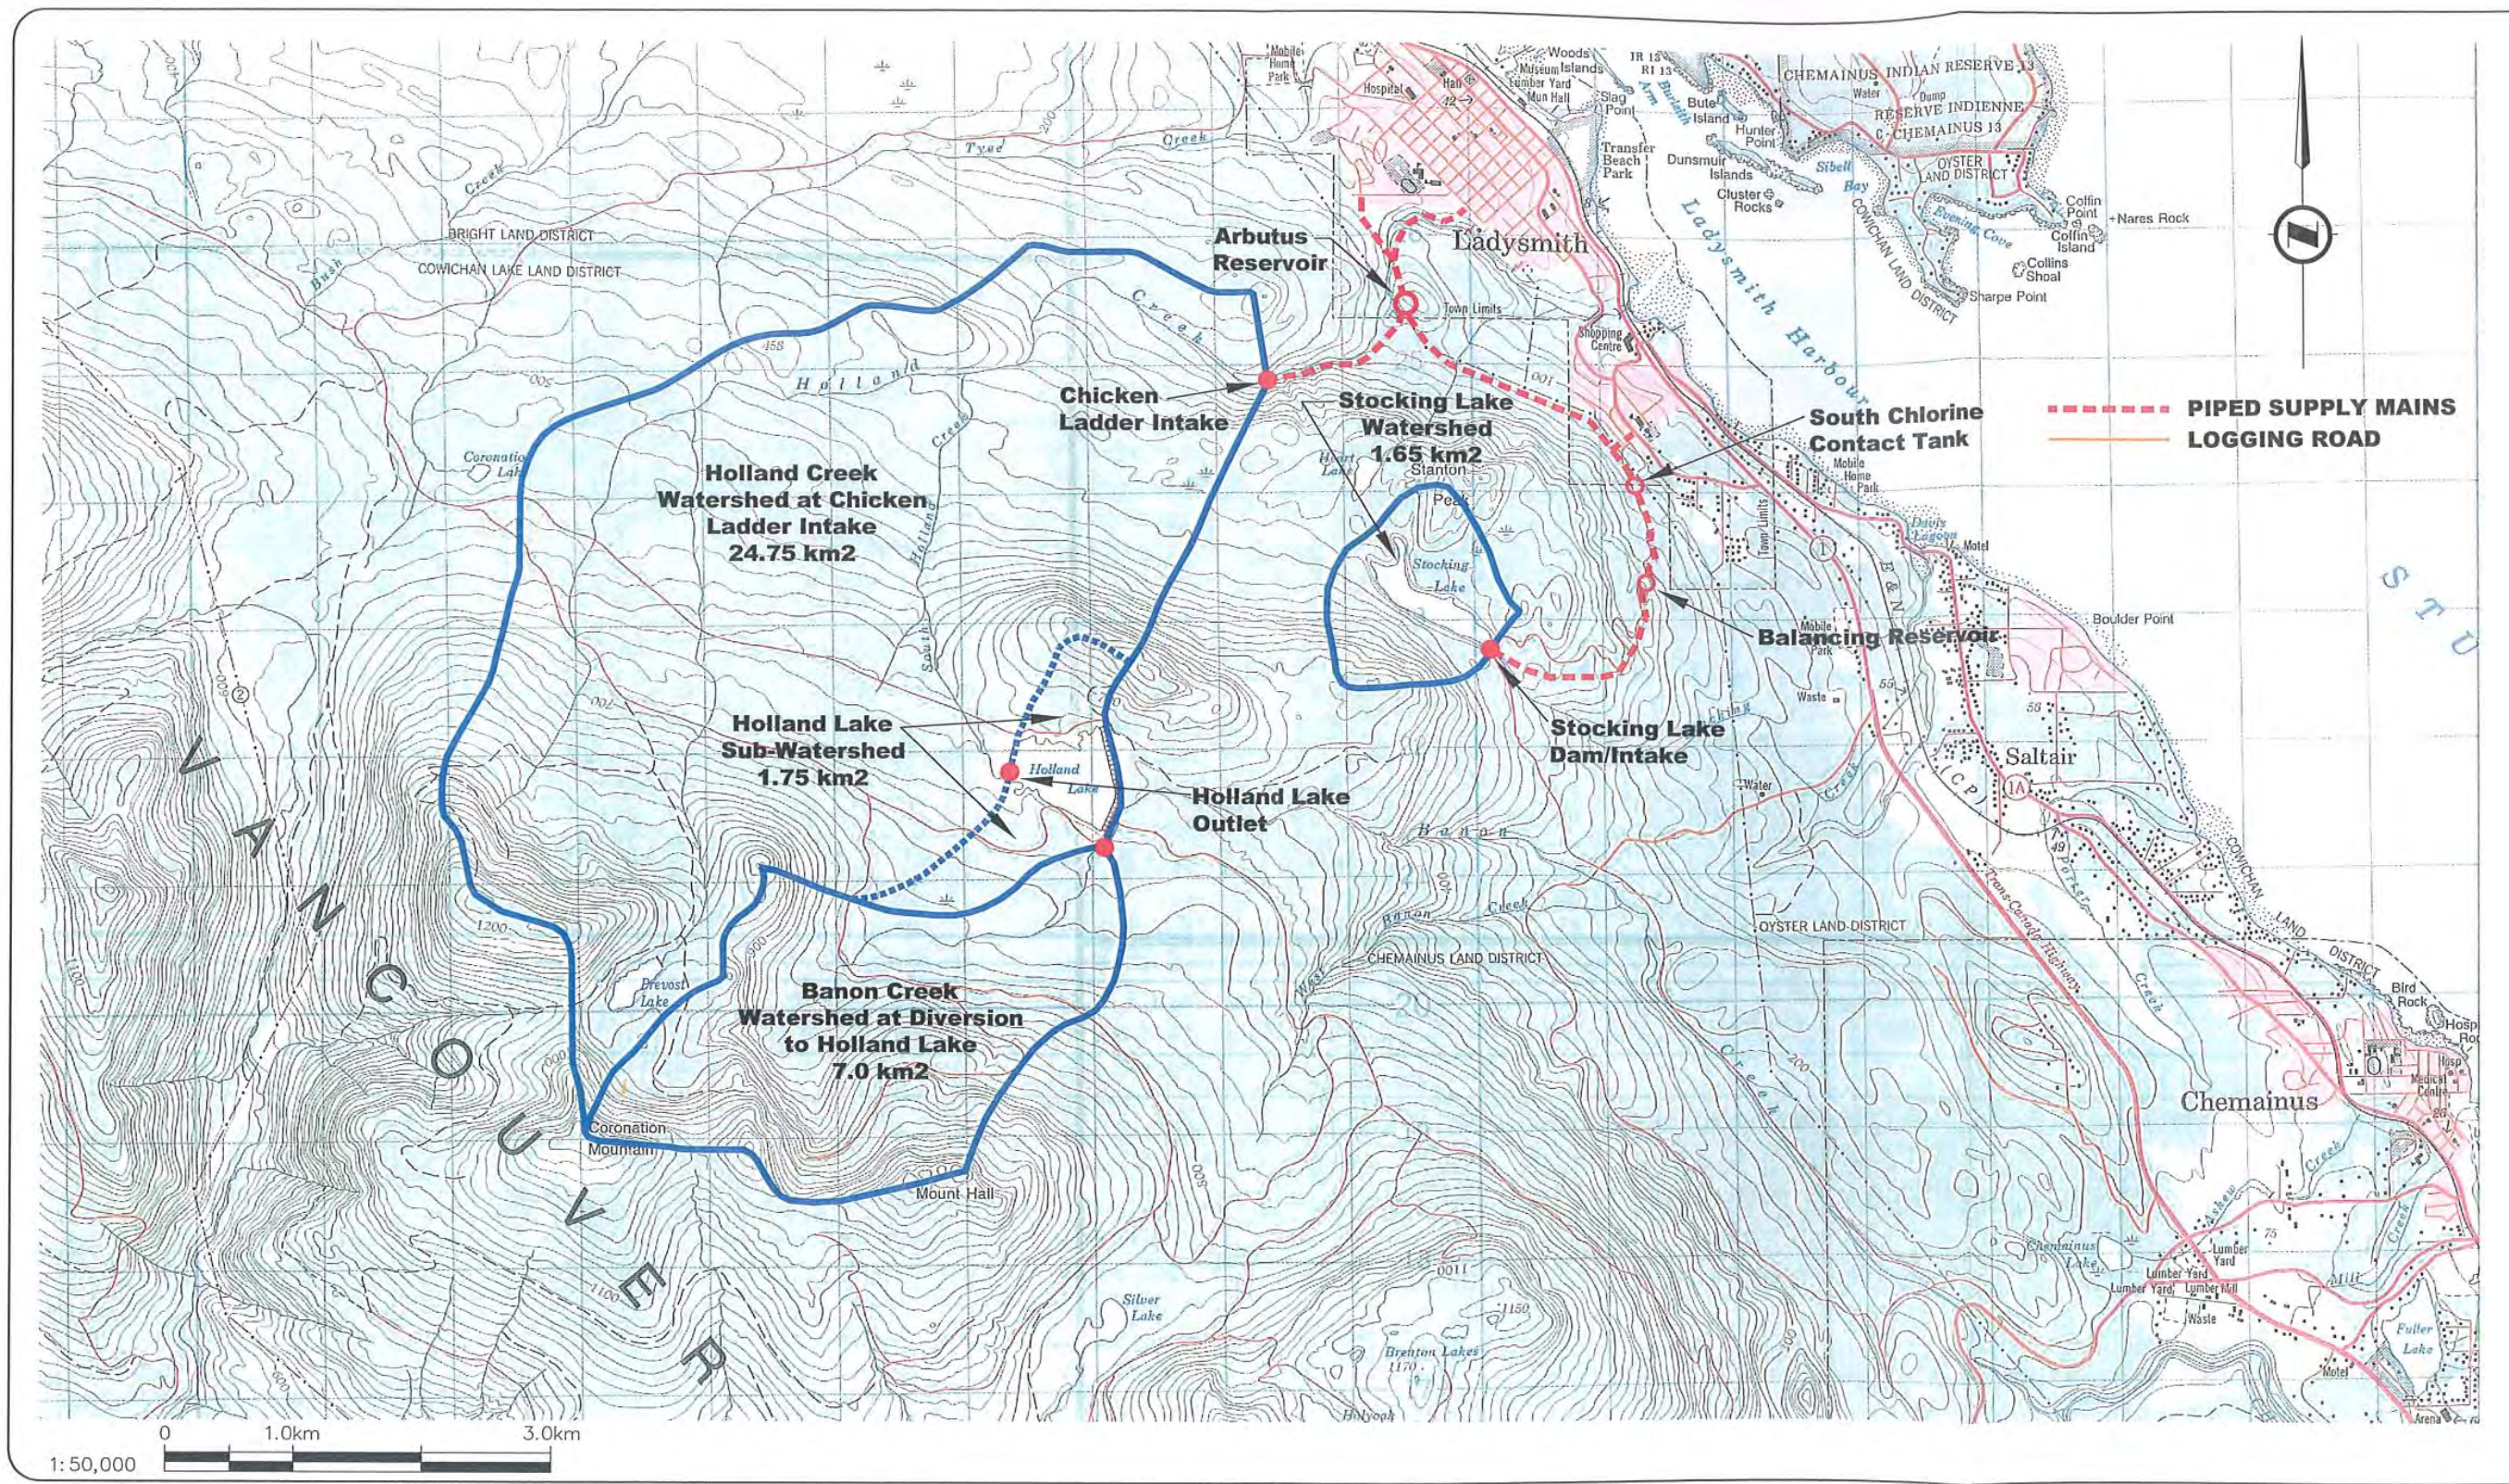
Figure 1 System Overview

Figure 1 shows the general layout of the Watersheds and major storage and intake structures.

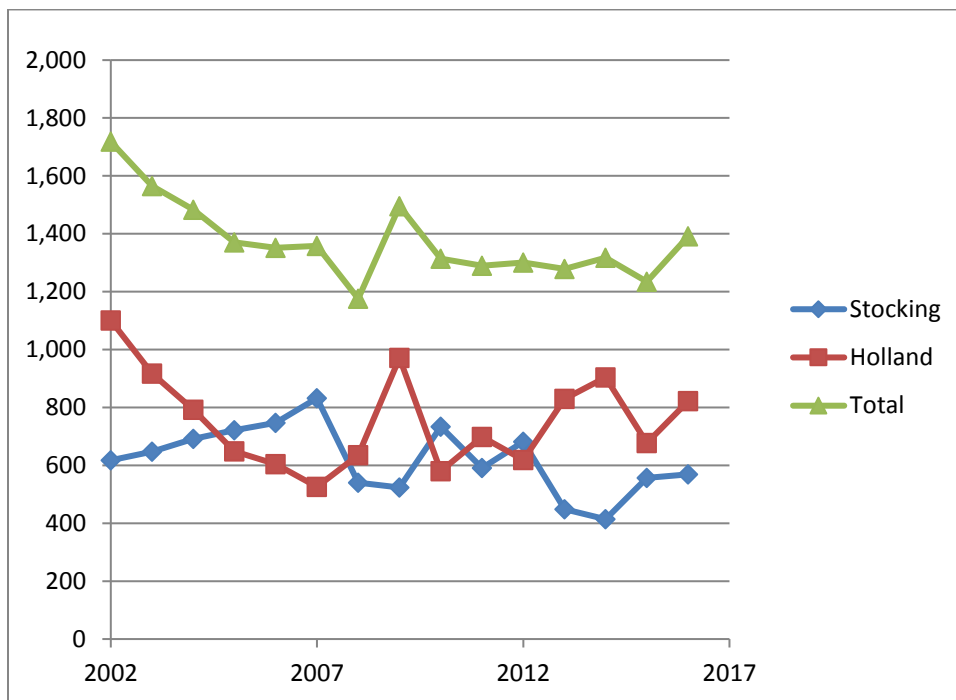
Figure 2
Ladysmith Total Consumption and Flow Source – 2002-2016
(In Thousands of cubic meters)

A summary of water consumption by month, including the flow splits between Stocking Lake and Chicken Ladder Intake (Holland Creek) follows on the next page, illustrated as follows:

The general downward trend in water consumption is likely the result of the Town's decision to install residential water meters in 2006, as well as its progressive block pricing rate structure for single family residential water accounts. The Town has also been encouraging water conservation through programs such as a toilet rebate program, which would also have a downward impact on consumption.

Over the last 11 years, the Town has used roughly equal amounts of water from Holland and Stocking watersheds. This has occurred primarily for two reasons: Firstly, until the fall of 2012, portions of South Ladysmith were incapable of feeding from the Holland Watershed due to piping and chlorination equipment considerations. In 2012, installation of a two-way interconnecting pipe system connected the Stocking Lake supply line directly to the Arbutus Reservoir. Upon completion of this project, the old chlorination facility servicing South Ladysmith was taken out of service, and all chlorination is now taking place near the Arbutus Reservoir. This has had the effect of allowing an additional 100,000 cubic meters of Holland Creek water to be able to serve South Ladysmith during times when Holland Creek has acceptable turbidity levels.
