2015

Annual Water Report

Town of Ladysmith

Infrastructure Services

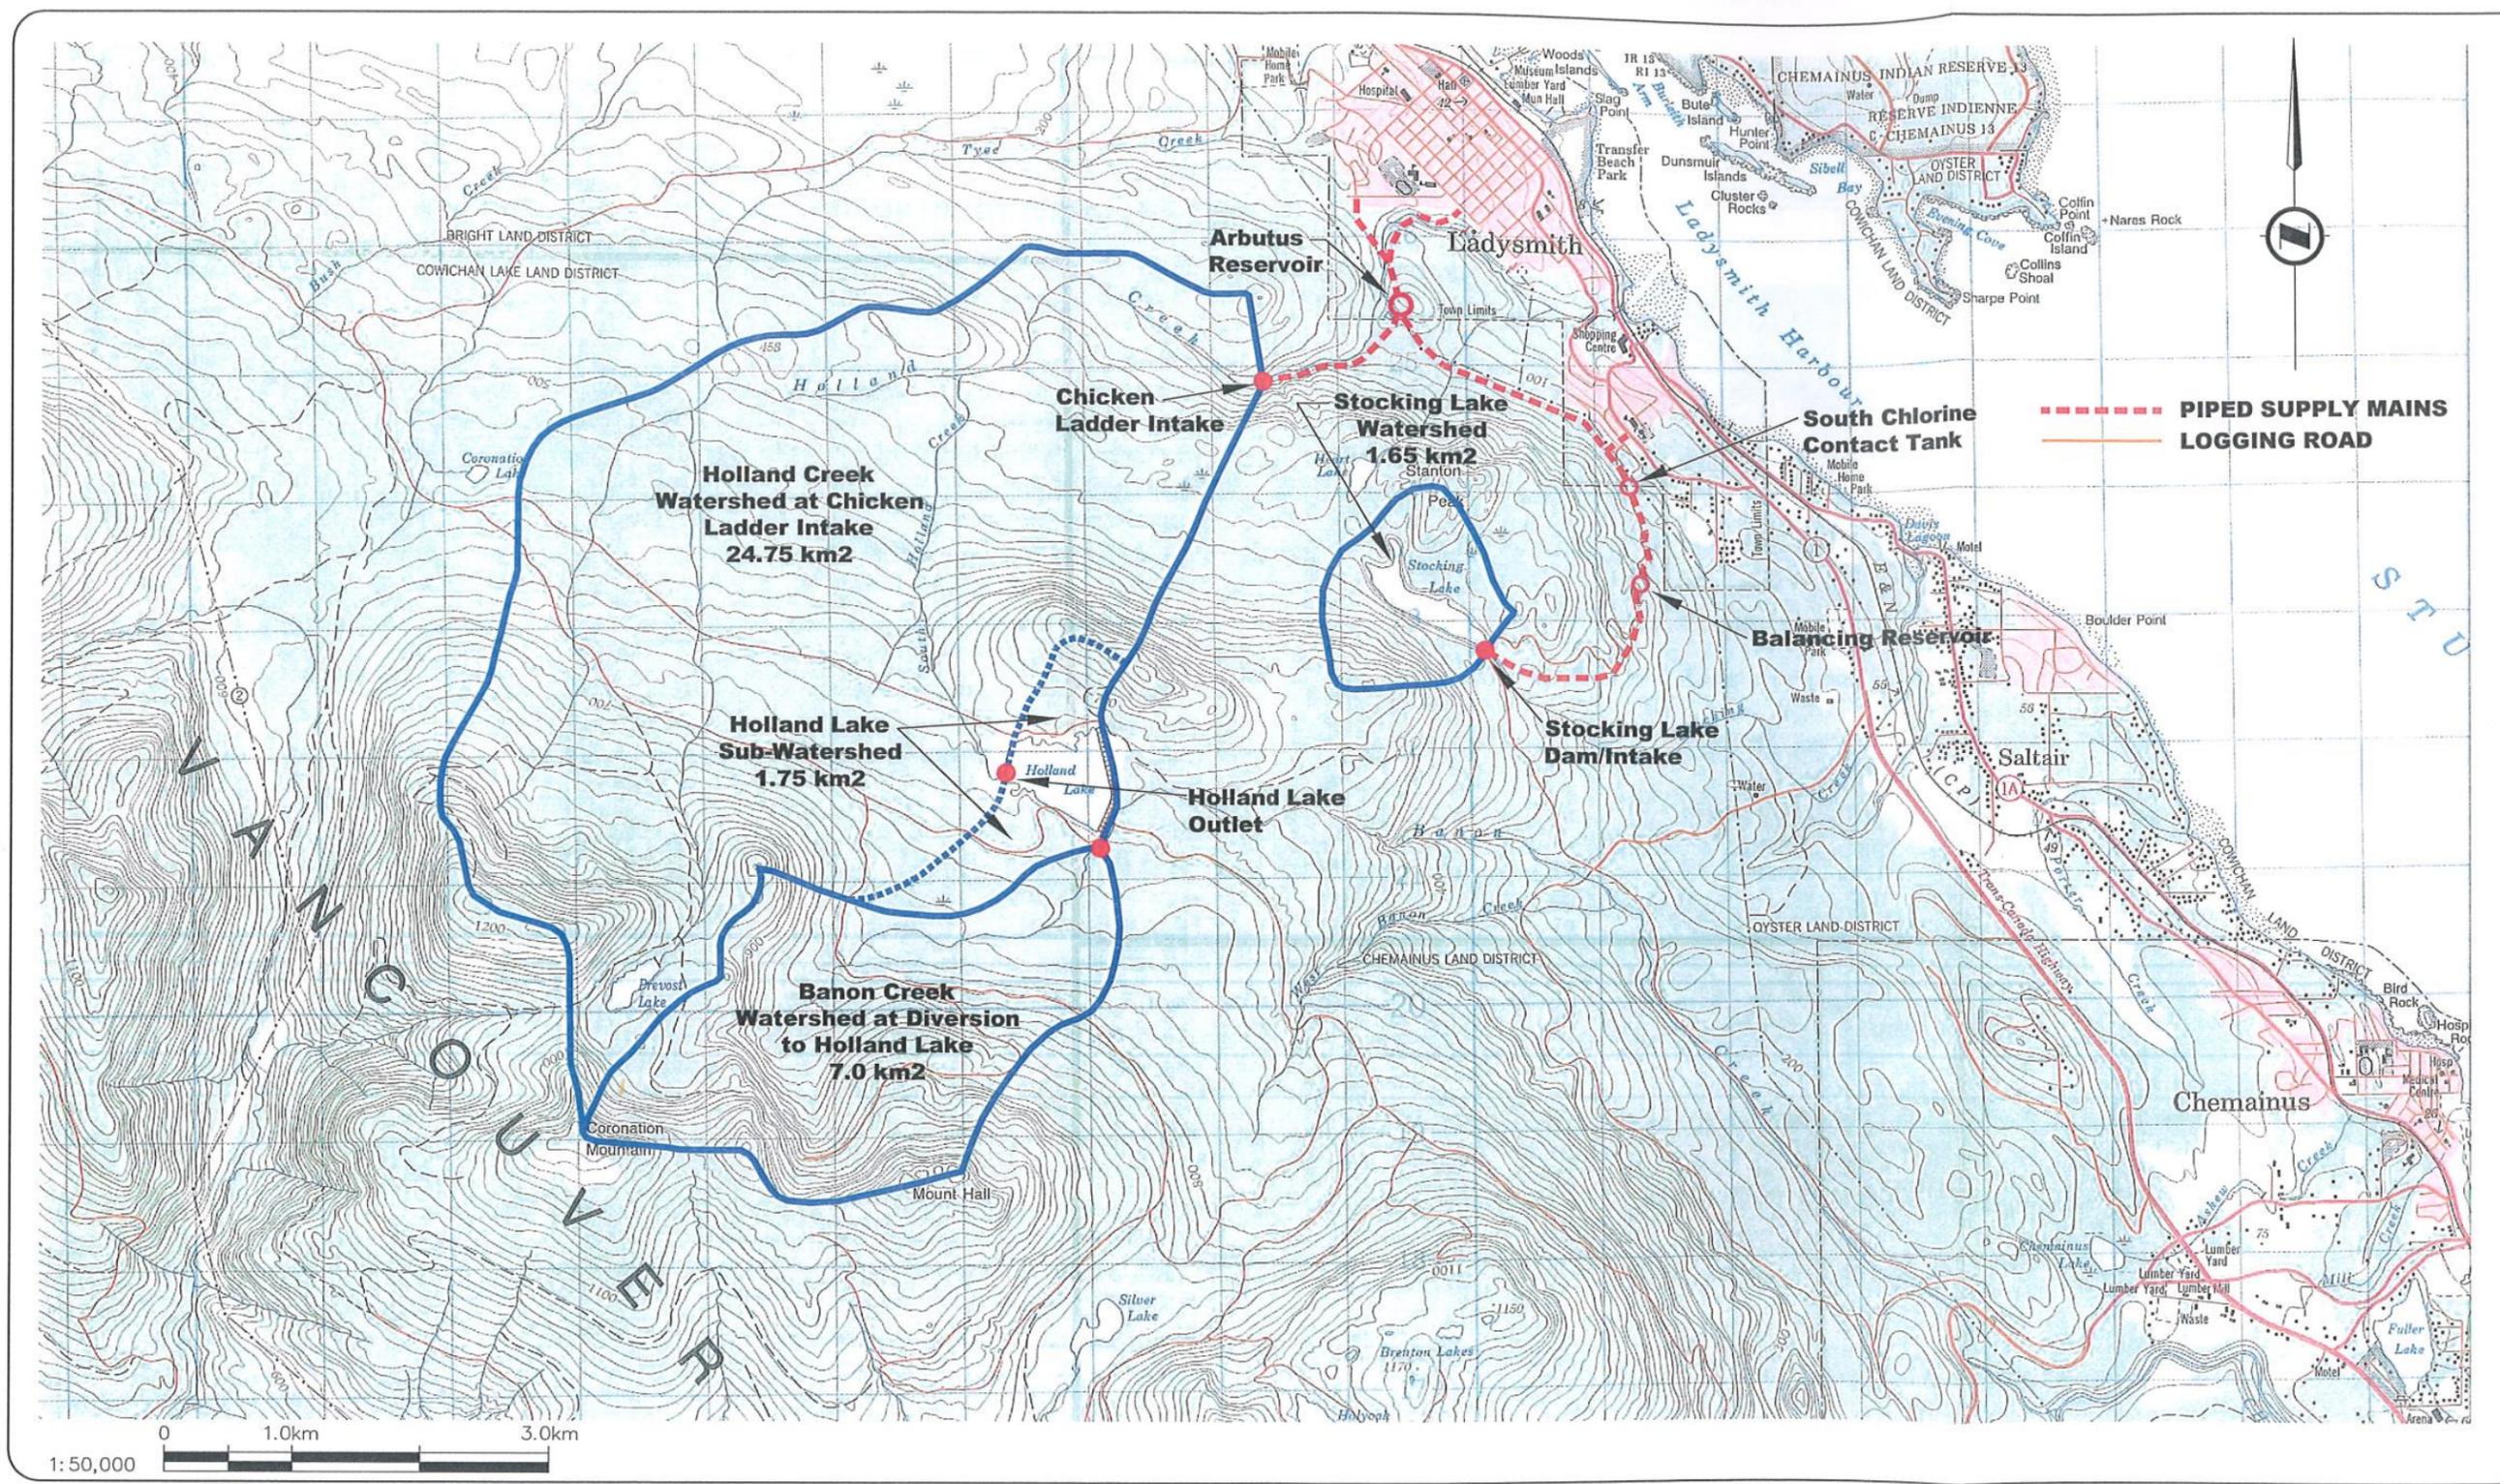
Figure 1 System Overview

Figure one shows the general layout of the Watersheds and major storage and intake structures.

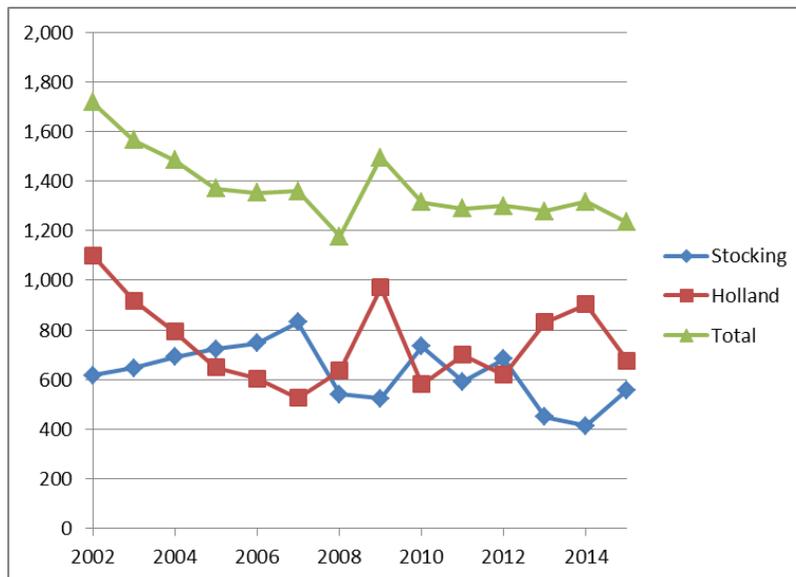
Figure 2
Ladysmith Total Consumption and Flow Source – 2002-2015
(In Thousands of cubic meters)

A summary of water consumption by month, including the flow splits between Stocking Lake and Chicken Ladder Intake (Holland Creek) follows on the next page, and is illustrated as follows:

The Town used 1,234,000 cubic meters of water in 2015, a decrease of 6.0% over 2014, and considerably less than the consumption in 2002 (1.7M cu m). This reflects a trend that has been occurring at the Town since residential water metering was introduced in 2006. The Town is using approximately 25% less water now than 11 years ago (2002 annual consumption was 1,700,000 cu m). During the same period, the Town has grown over 23%, resulting in a net reduction of per capita water consumption in the order of 47%. The decrease is also a result of the 2015 water sprinkler restriction program, which saw summer flows reduced considerably over previous years.

The general downward trend in water consumption is likely the result of the Town's decision to install residential water meters in 2006, as well as its progressive block pricing rate structure for single family residential water accounts. The Town has also been encouraging water conservation through programs such as a toilet rebate program, which would also have a downward impact on consumption.
